CONTENTS

Revision: October 2005 PR-3 2005 Armada

FRONT PROPELLER SHAFT

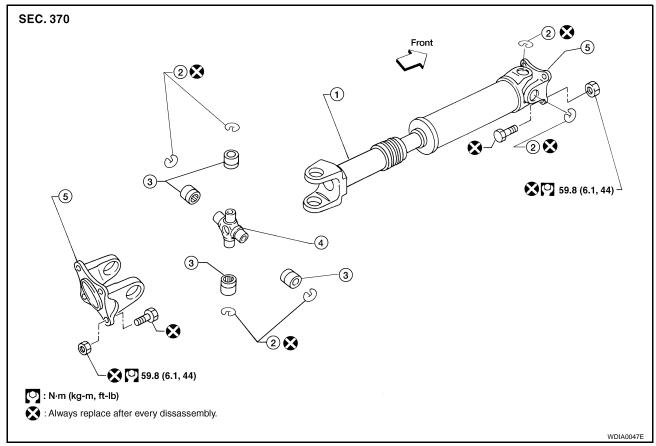
Model 2F1310

- 1. Propeller shaft tube
- 2. Snap ring

Journal bearing

4. Journal

5. Flange yoke

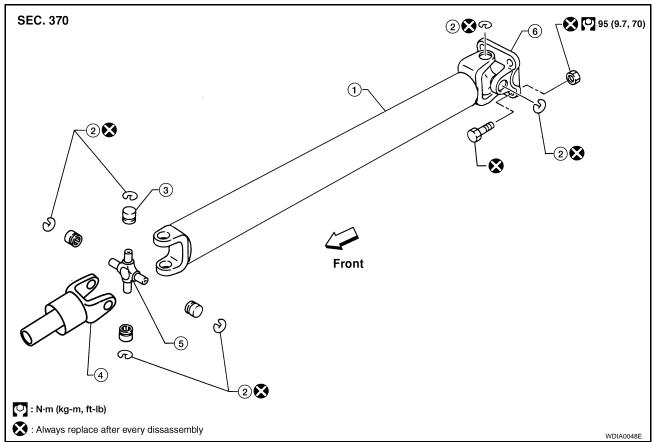
Model 2S1350

- 1. Propeller shaft tube
- Snap ring

Journal bearing

4. Sleeve yoke

Journal

Flange yoke
