CONTENTS

FRONT WHEEL HUB AND KNUCKLE

FAX-7 Revision; 2004 April 2003 G35 Coupe

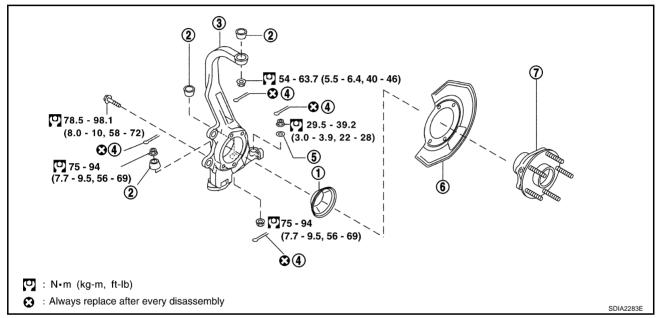
1. Hub cap

- 2. Ball seat
- 3. Steering knuckle

Cotter pin

Washer

6. Splash guard

7. Wheel hub and bearing assembly

Refer to <u>FAX-4</u>, "<u>Removal and Installation</u>" for tightening torque. Install in the reverse order of removal.
 CAUTION:

Refer to component parts location and do not reuse non-reusable parts.

Wheel hub and bearing assembly and disc must be installed to fit the marked position each other.
