SQUEAK AND RATTLE TROUBLE DIAGNOSES

IP-5 2005 350Z Revision: 2005 August

INSTRUMENT PANEL ASSEMBLY

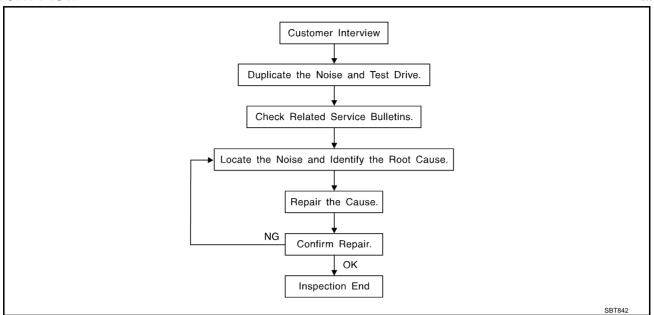
Work Flow

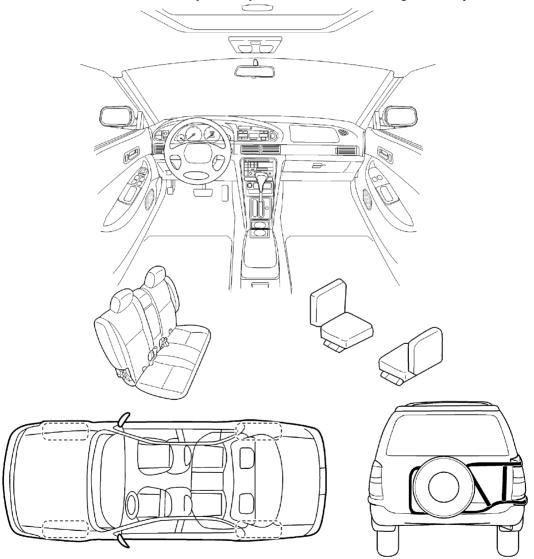
PIIB0723E

I. WHERE DOES THE NOISE COME FROM? (circle the area of the vehicle)

The illustrations are for reference only, and may not reflect the actual configuration of your vehicle.

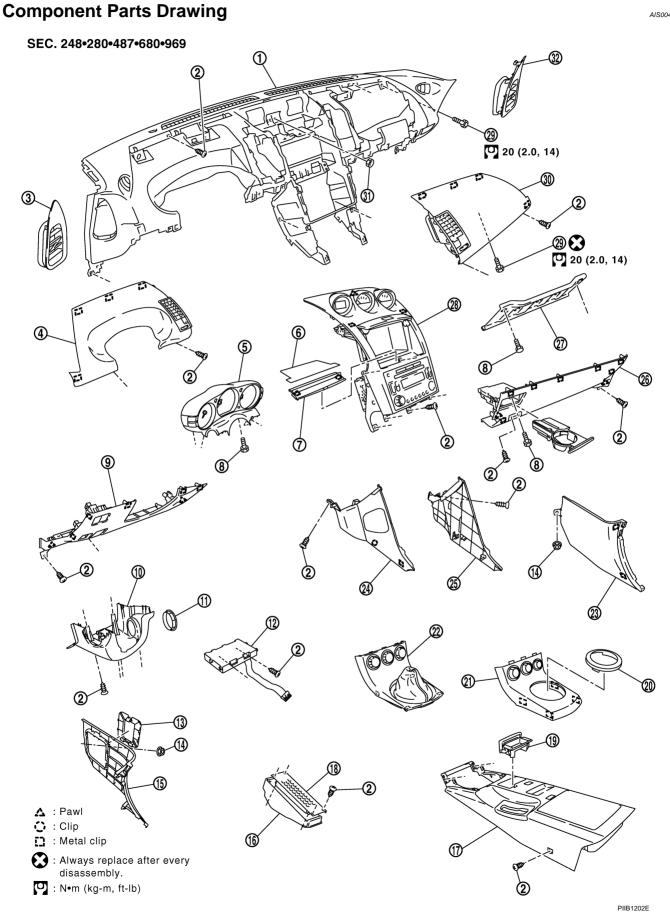
1	1.	Instrument panel	2.	Screw	3.	Instrument side finisher
4	4.	Instrument driver panel upper	5.	Combination meter	6.	Pocket mat
7	7.	Switch mask	8.	Bolt	9.	Instrument driver panel lower
1	10.	Steering column cover	11.	Steering lock escutcheon	12.	Unified meter and A/C amp.
1	13.	Fuse cover	14.	Nut (plastics)	15.	Dash side finisher (LH)
1	16.	Foot rest	17.	Center console	18.	Foot rest plate
1	19.	Coin holder / Ashtray	20.	Console finisher (A/T ring)	21.	Console finisher (A/T)
2	22.	Console boot (M/T)	23.	Dash side finisher (RH)	24.	Instrument side panel (LH)
2	25.	Instrument side panel (RH)	26.	Instrument passenger panel lower	27.	Knee protector
2	28.	Cluster lid C	29.	Bolt	30.	Instrument passenger panel upper
3	31.	Nut	32.	Instrument side finisher (RH)

When removing instrument panel, combination meter, audio and console assembly, take steps in the order shown by the numbers below.

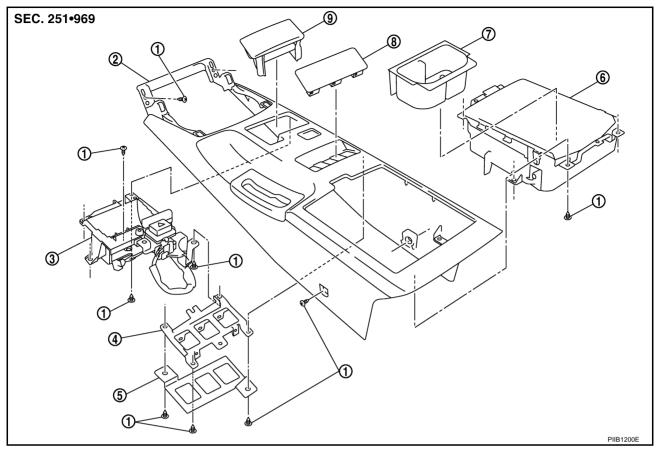
Disassembly and Assembly CENTER CONSOLE

- 1. Screw
- 4. Switch bracket
- 7. Console tray

- 2. Center console
- 5. Bracket
- 8. Console cover mask
- 3. Coin holder bracket
- 6. Console rear pocket
- 9. Coin holder / Ashtray

Assemble in the reverse order of disassembly.

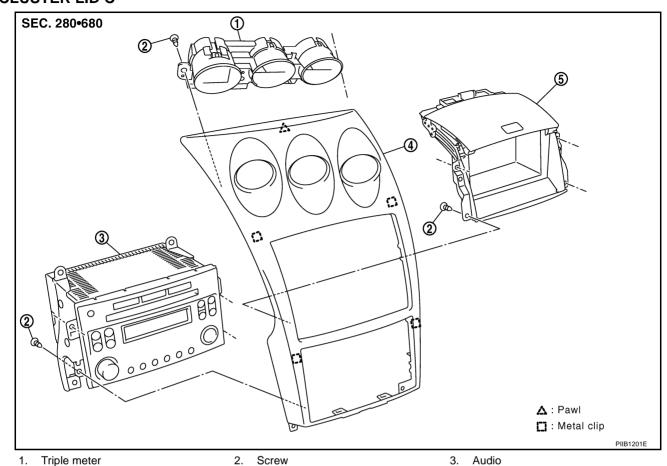
CLUSTER LID C

- 5.

4. Cluster lid C
