SECTION **BRM**
BODY REPAIR

BODY REPAIR

Body Exterior Paint Color

UNDERBODY COMPONENT PARTS

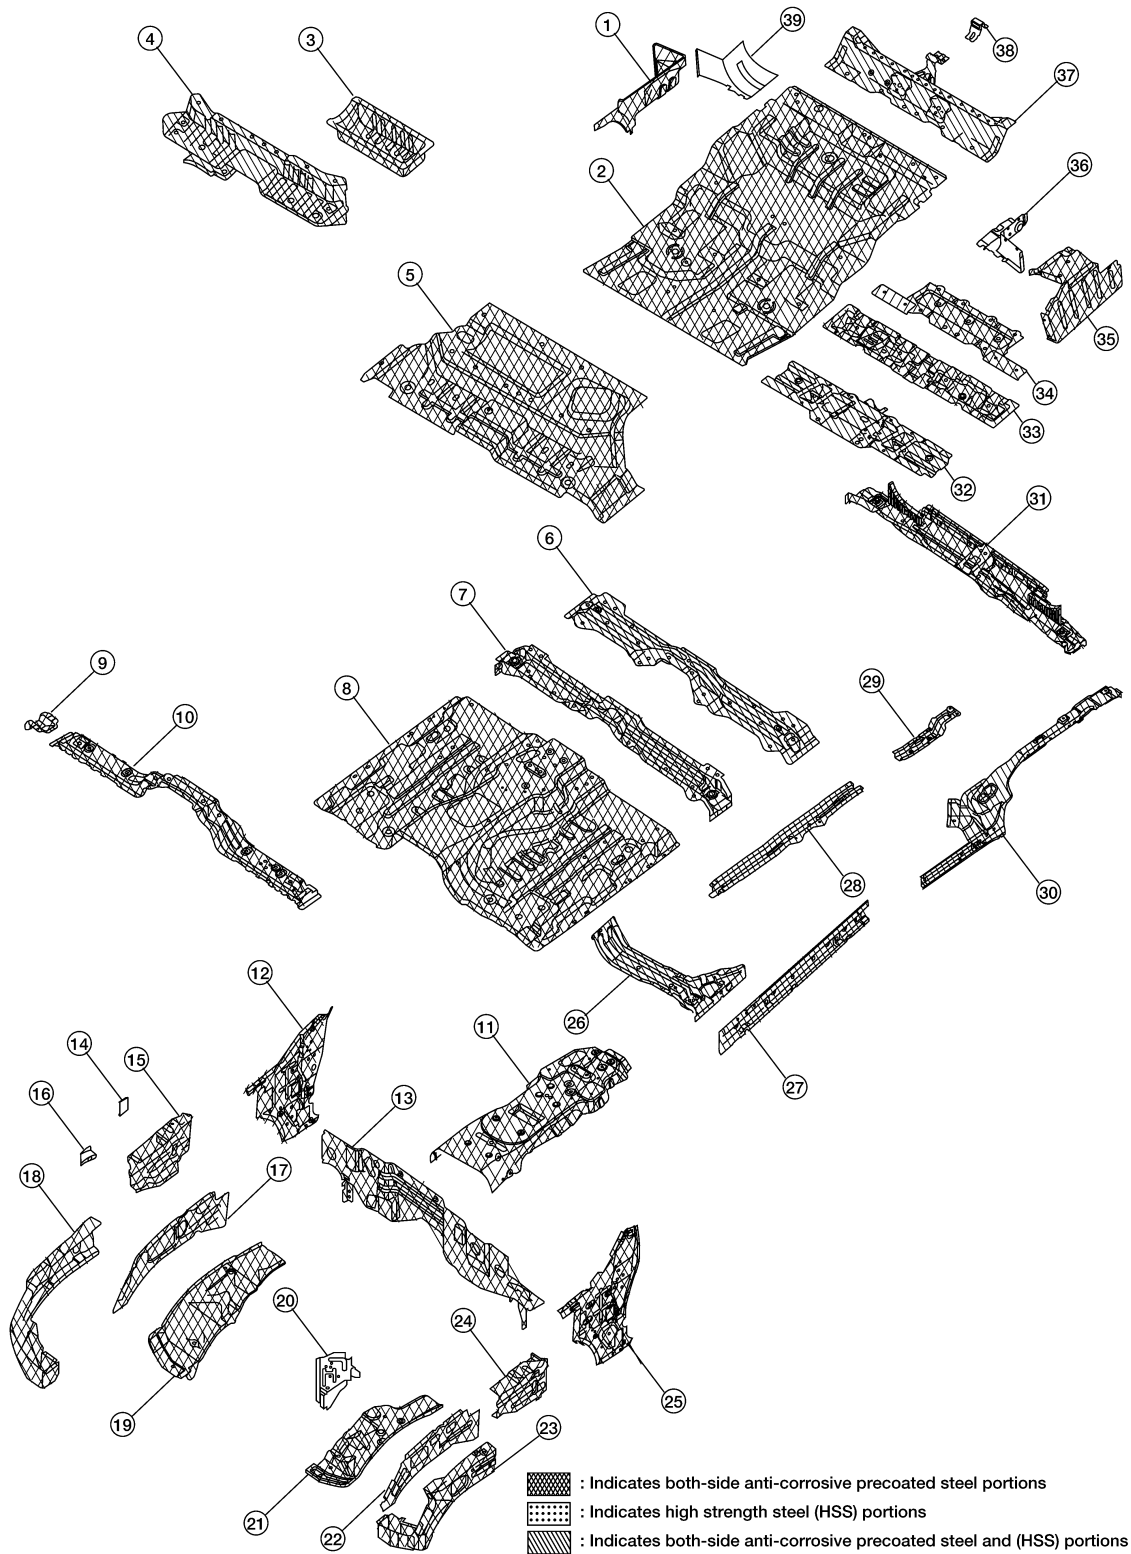
LIA1787E

1. Rear floor side RH
2. Rear floor
3. Storage bin
4. Second seat mounting crossmember

5. Rear floor front
6. Center pillar crossmember assembly
7. Front seat mounting rear crossmember
8. Front floor
9. Front seat mounting crossmember
10. Second crossmember extension

11. Front floor reinforcement
12. Side dash RH
13. Lower dash
14. Wash tank bracket
15. Hoodledge reinforcement RH
16. Hoodledge plate
17. Hoodledge RH
18. Hoodledge reinforcement assembly RH

19. Rear lower hoodledge RH
20. Battery tray
21. Rear lower hoodledge LH
22. Hoodledge LH
23. Hoodledge reinforcement assembly LH
24. Hoodledge reinforcement LH

25. Side dash LH
26. Second crossmember assembly (RH/LH)
27. Inner sill (RH/LH)
28. Front side member assembly (RH/LH)
29. Center floor member assembly
30. Rear side member rear (RH/LH)

31. Rear crossmember
32. Second seat mounting crossmember
33. Third seat mounting bracket assembly
34. Rope hook bracket
35. Rear floor side LH
36. Rear floor side upper extension assembly LH

37. Third seat mounting rear crossmember assembly
38. Trim mounting bracket
39. Rear floor side upper extension assembly RH

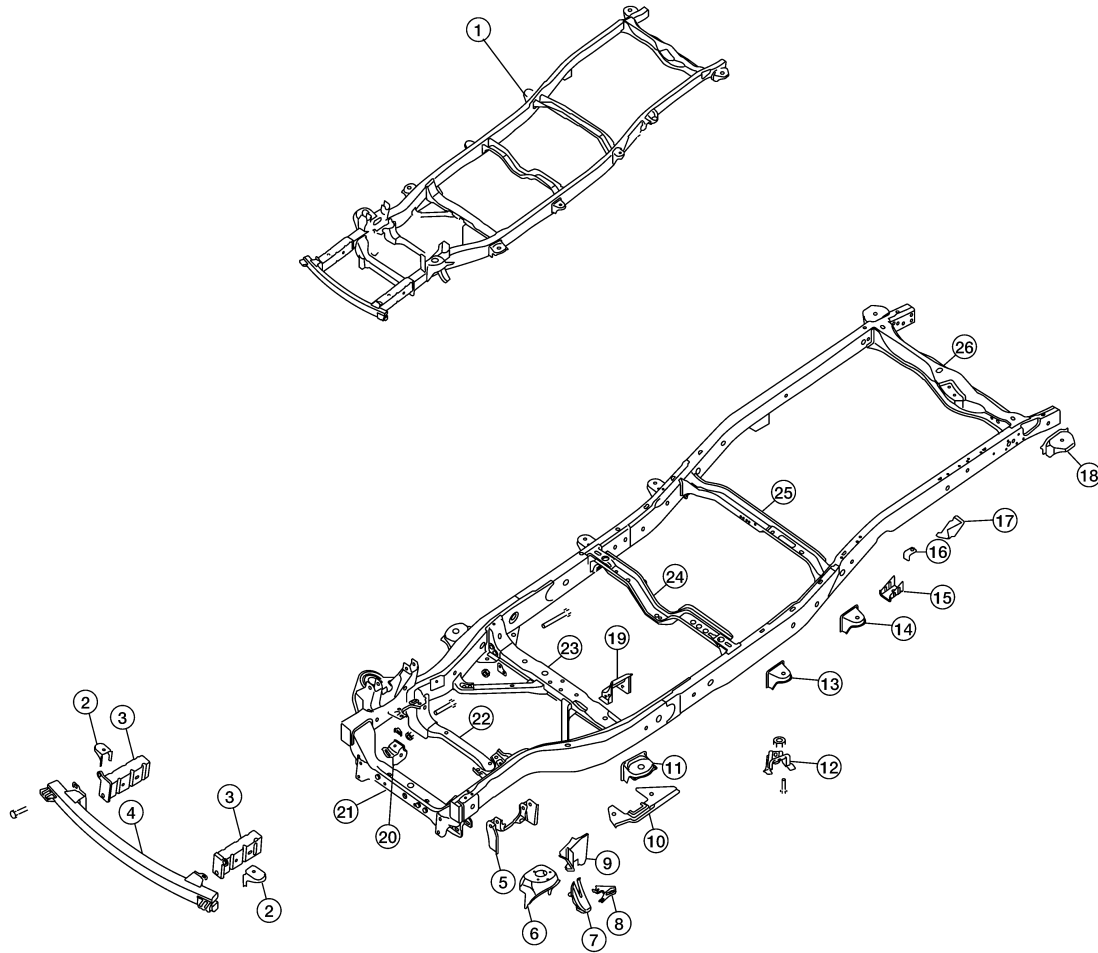
LIA1789E

1. Frame assembly
2. 1st cab mounting bracket RH/LH
3. Front side member extension assembly RH/LH
4. 1st crossmember assembly
5. Front upper link mounting bracket RH/LH

6. Front shock absorber mounting bracket RH/LH
7. Bound bumper bracket RH/LH
8. Front brake hose bracket RH/LH
9. Panhard rod bracket reinforcement
10. 4th crossmember gusset RH/LH
11. 2nd cab mounting bracket RH/LH
12. Crossmember support RH/LH
13. 3rd cab mounting bracket RH/LH
14. 4th cab mounting bracket RH/LH
15. Rear suspension mounting bracket RH/LH
16. Rear brake hose bracket
17. Rear bound bumper bracket RH/LH
18. Cab mounting bracket assembly RH/LH
19. 4th crossmember gusset RH/LH
20. Front differential mounting bracket RH/LH
21. 2nd crossmember assembly
22. 3rd crossmember assembly
23. 4th crossmember assembly
24. 5th crossmember assembly
25. 6th crossmember assembly
26. 9th crossmember assembly

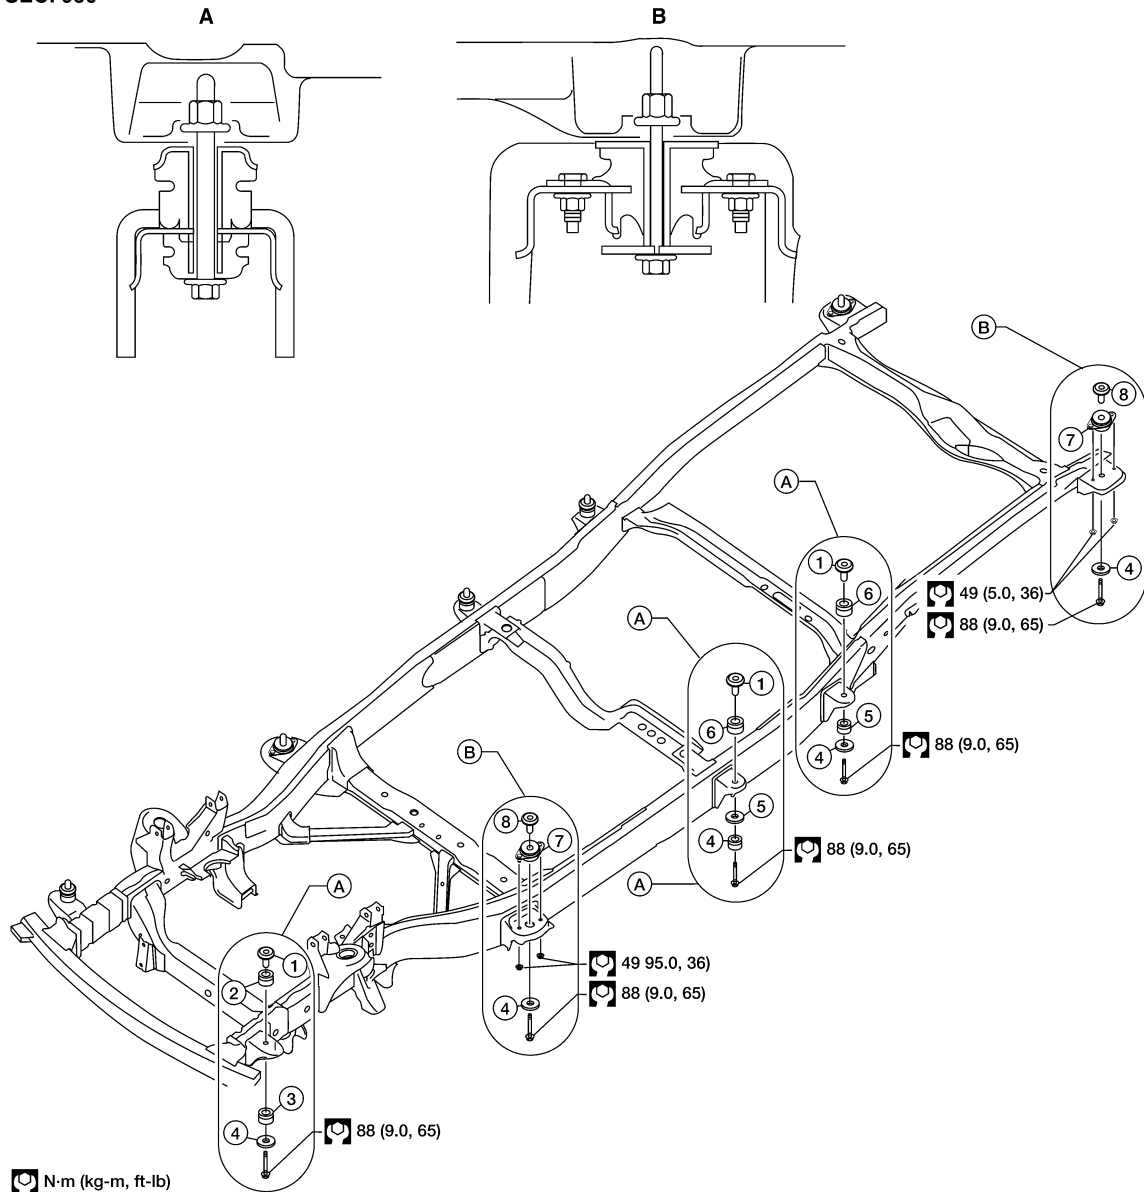
SEC. 930

- When removing, be sure to replace bolts and nuts (sealant applied bolts or self-lock nuts are used for all mounting).
- Unless otherwise noted, the bushings and insulators have paint marks that are to be installed facing outward.

| 1. Gold washer | 2. Upper bushing | 3. Lower bushing |
| 4. Black washer | 5. Lower bushing without paint mark | 6. Upper bushing without paint mark |
| 7. Body mount insulator | 8. Body washer | |

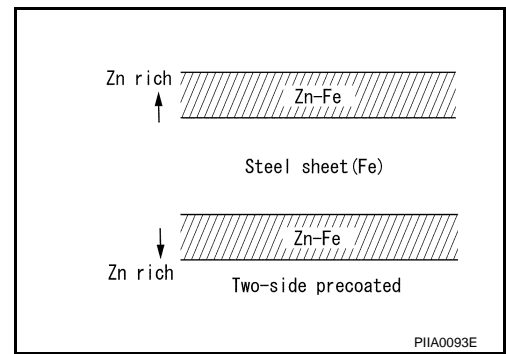
To improve reparability and corrosion resistance, a new type of anti-corrosive pre-coated steel sheet has been adopted replacing conventional zinc-coated steel sheet.

Galvannealed steel is electroplated and heated to form Zinc-iron alloy, which provides excellent and long term corrosion resistance with cationic electrode position primer.

Nissan Genuine Service Parts are fabricated from galvannealed steel. Therefore, it is recommended that GENUINE NISSAN PARTS or equivalent be used for panel replacement to maintain the anti-corrosive performance built into the vehicle at the factory.

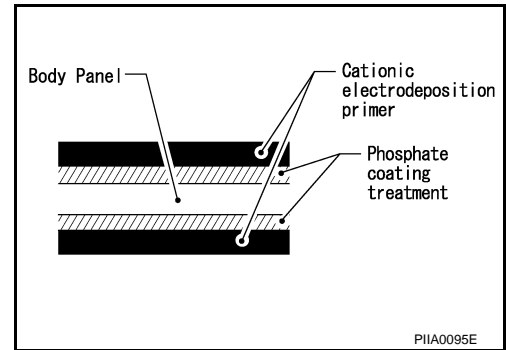
A phosphate coating treatment and a cationic electrode position primer, which provide excellent corrosion protection, are employed on all body components.

Confine paint removal during welding operations to an absolute minimum.

Nissan Genuine Service Parts are also treated in the same manner. Therefore, it is recommended that GENUINE NISSAN PARTS or equivalent be used for panel replacement to maintain anti-corrosive performance built into the vehicle at the factory.

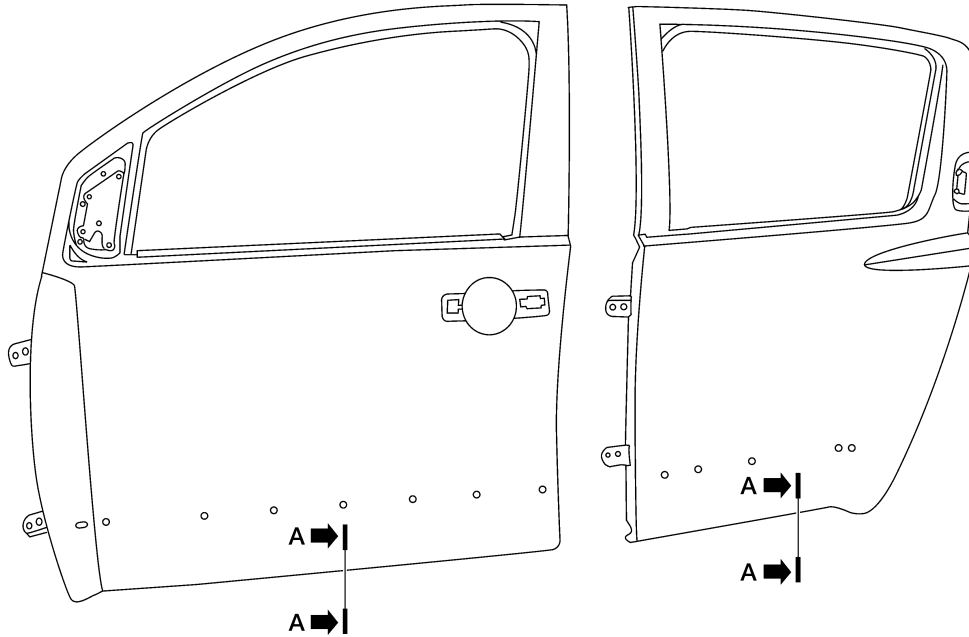
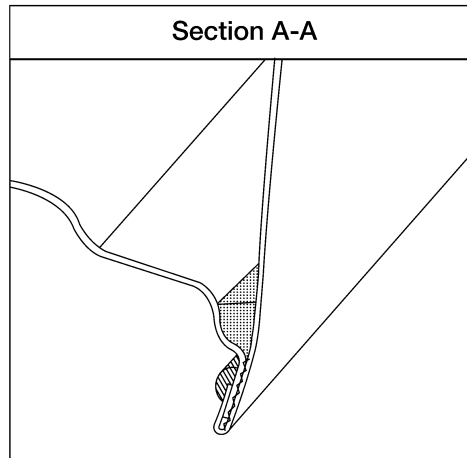
LIA0905E

To improve corrosion resistance, anti-corrosive wax is applied inside the body sill and inside other closed sections. Accordingly, when replacing these parts, be sure to apply anti-corrosive wax to the appropriate areas of

the new parts. Select an excellent anti-corrosive wax which will penetrate after application and has a long shelf life.

: Indicates outside body sealant

: Indicates anti-corrosive wax coated portions

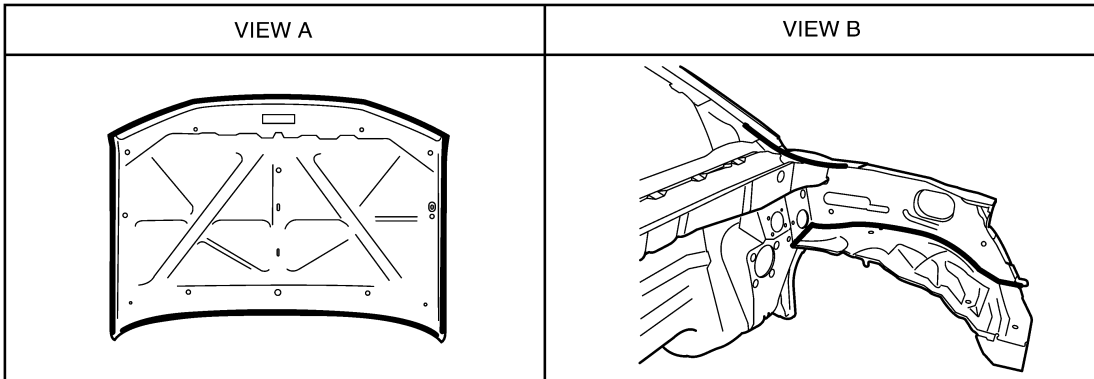
LIA1736E

The following figure shows the areas which are sealed at the factory. Sealant which has been applied to these areas should be smooth and free from cuts or gaps. Care should be taken not to apply an excess amount of sealant and not to allow other unaffected parts to come into contact with the sealant.

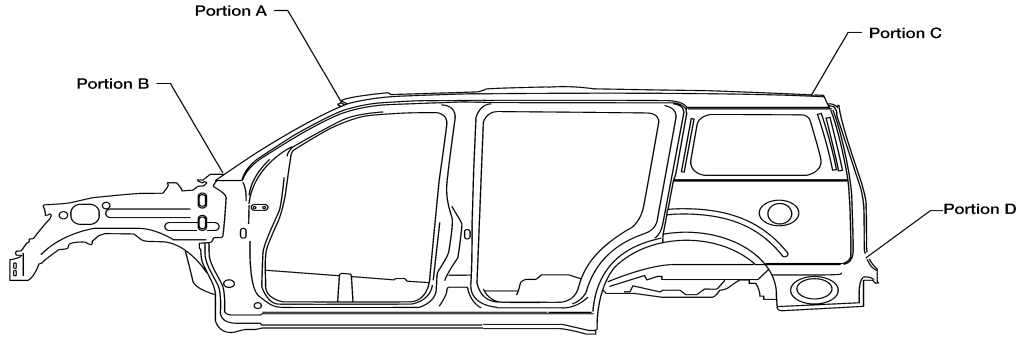
A mark has been placed on each part of the body to indicate the vehicle center. When repairing parts damaged by an accident which might affect the vehicle frame (members, pillars, etc.), more accurate and effective repair will be possible by using these marks together with body alignment specifications.

Portion A	Portion B	Portion C

<p>Embossment</p>

<p>Flange end</p>

<p>Notch</p>

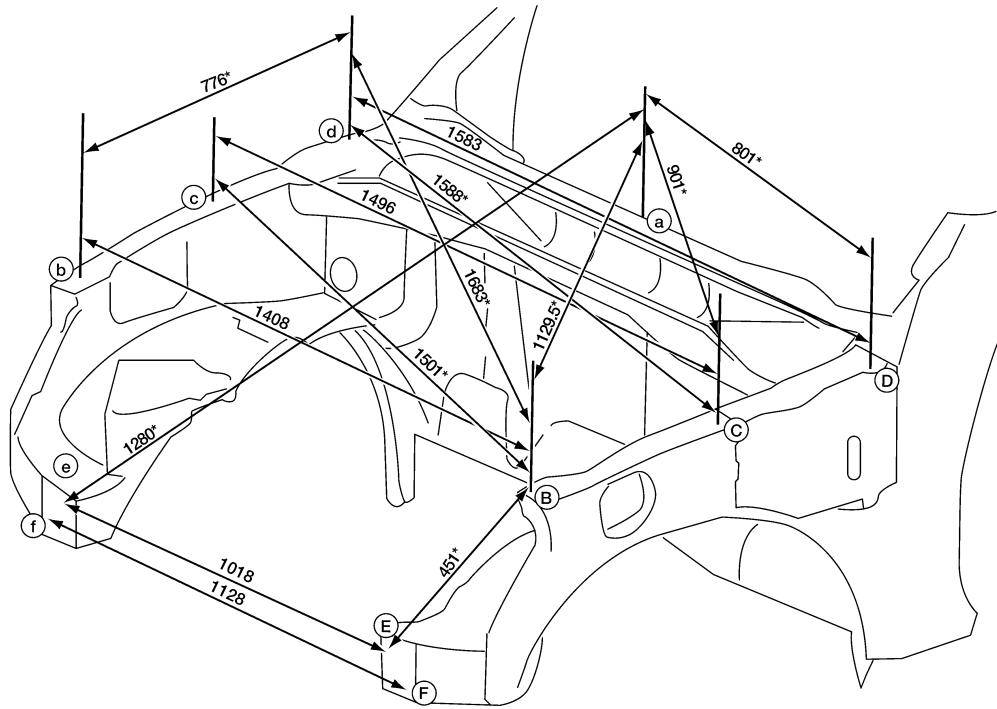
WIIA0729E

All dimensions indicated in this figure are actual.

Figures marked with an (*) indicate symmetrically identical dimensions on both right and left hand sides of the vehicle.

Unit: mm

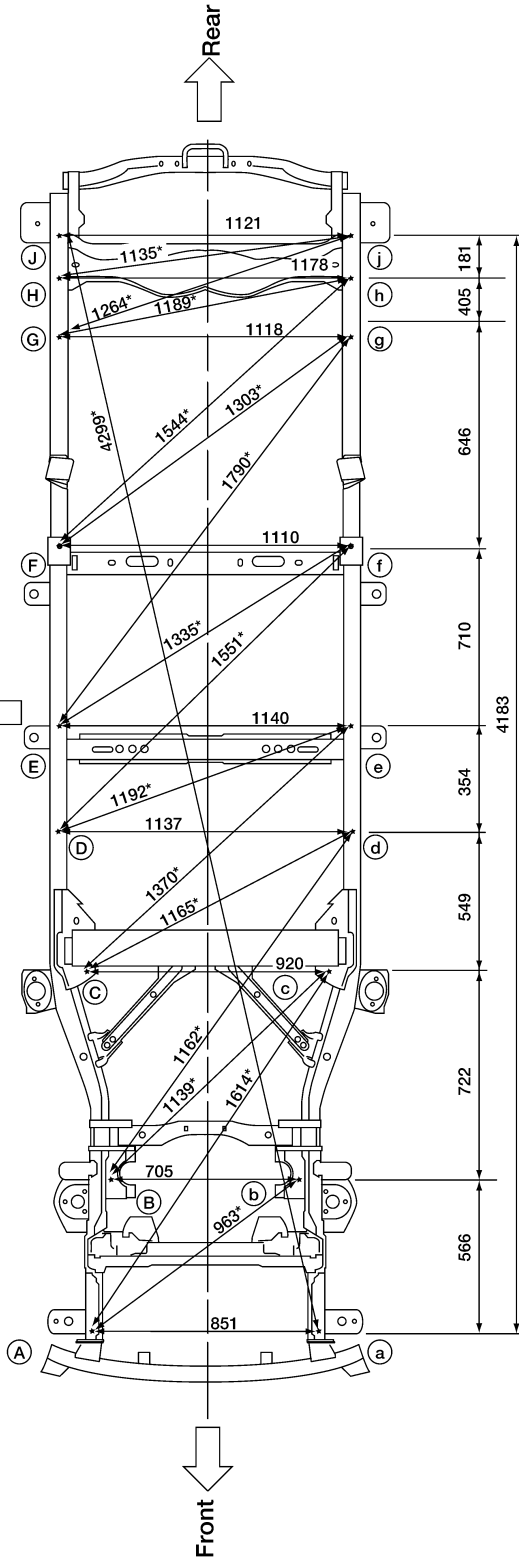
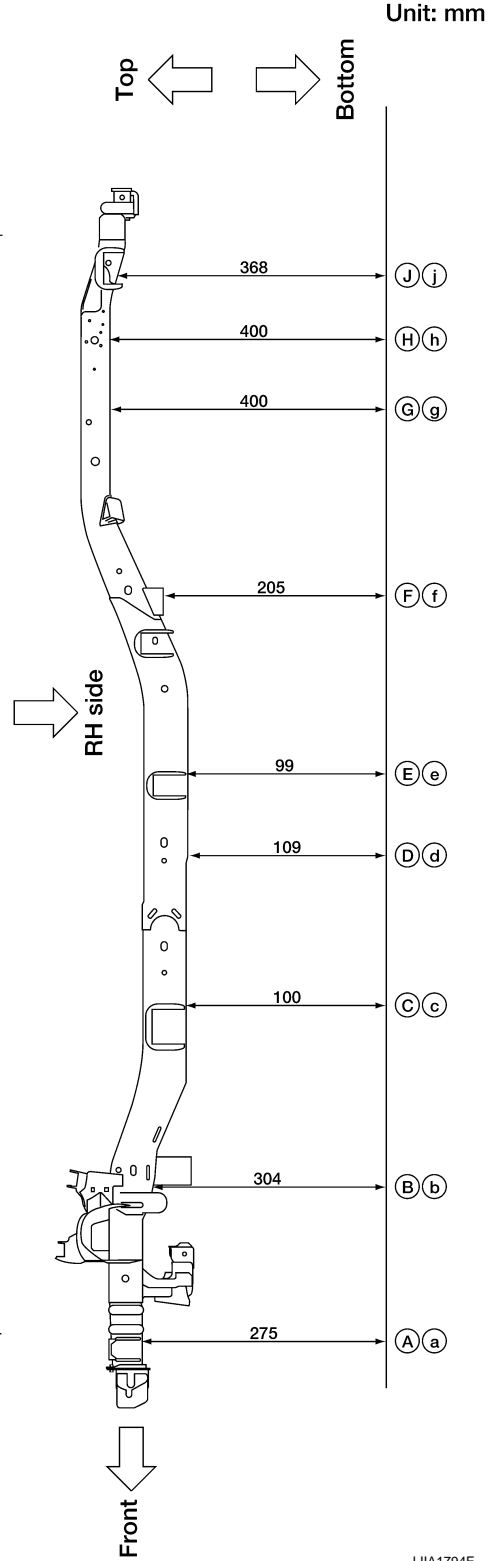
LIA1794E

Figures marked with a (*) indicate symmetrically identical dimensions on both right and left hand sides of the vehicle.

As viewed from underside.

All dimensions indicated in this figure are actual.

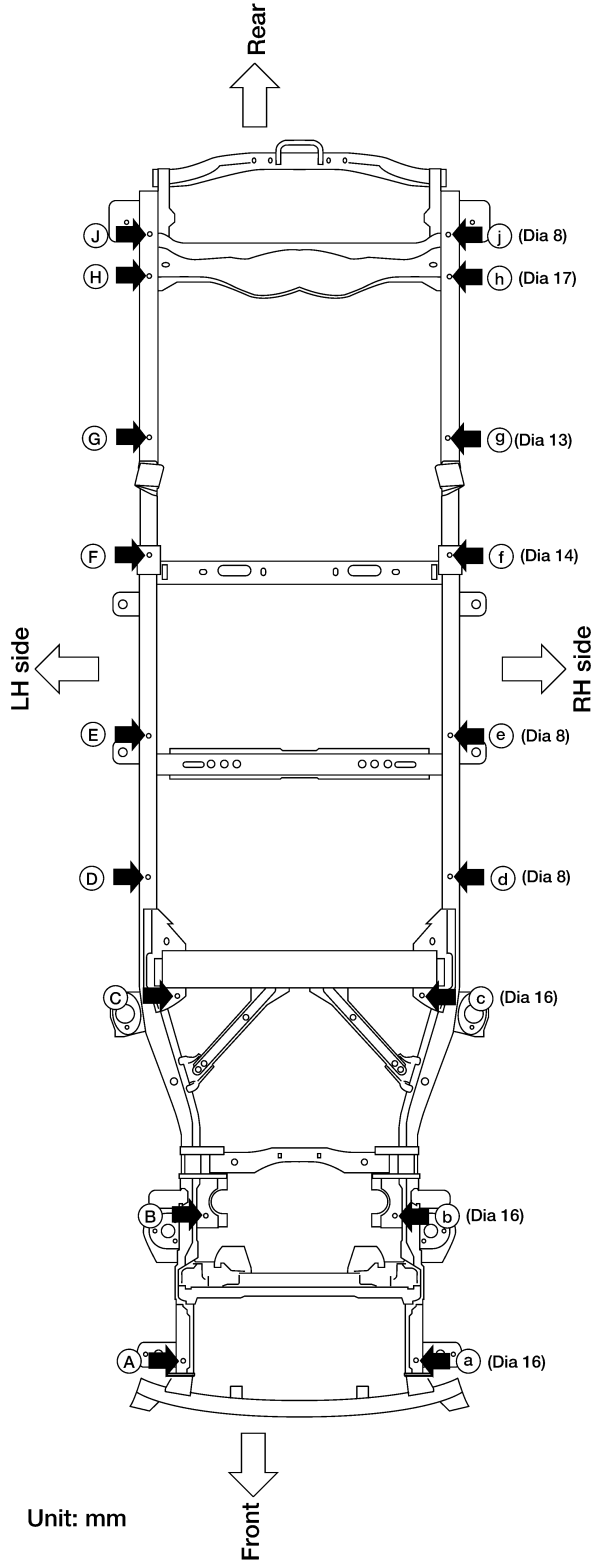
LIA1795E

Coordinates:

- (A, a)
X : ± 425
Y : -531
Z : 275
- (B, b)
X : ± 353
Y : 35
Z : 304
- (C, c)
X : ± 460
Y : 807
Z : 100
- (D, d)
X : ± 568
Y : 1356
Z : 109
- (E, e)
X : ± 570
Y : 1710
Z : 99
- (F, f)
X : ± 555
Y : 2420
Z : 205
- (G, g)
X : ± 559
Y : 3066
Z : 400
- (H, h)
X : ± 559
Y : 3471
Z : 400
- (J, j)
X : ± 560
Y : 3652
Z : 368

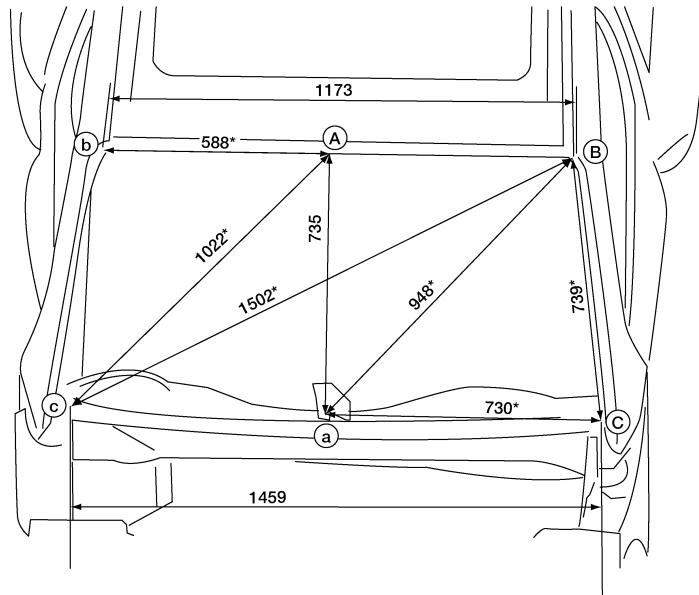
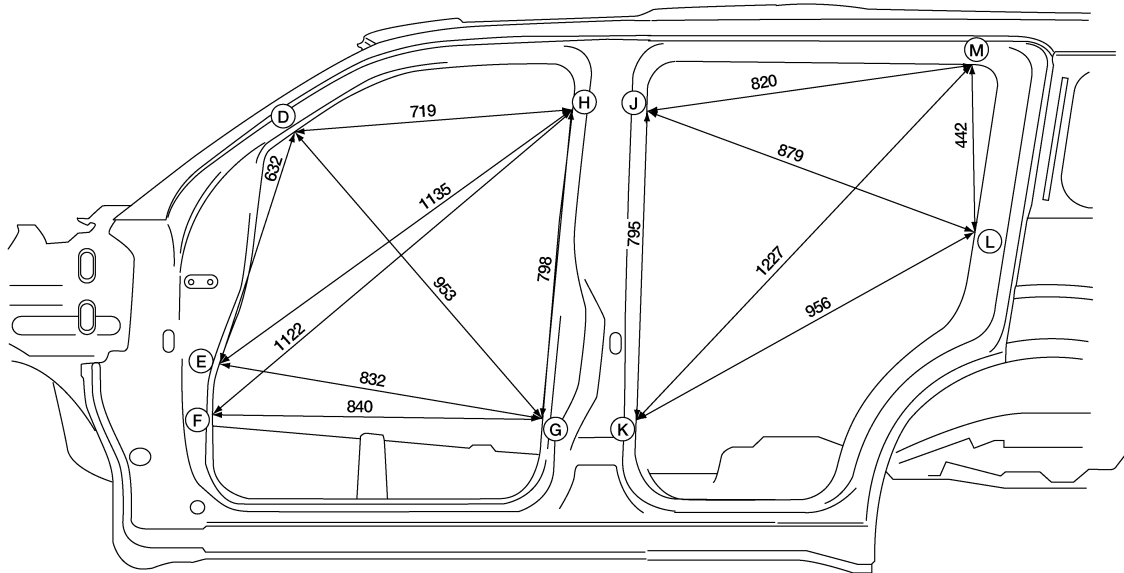
LIA1798E

Figures marked with a (*) indicate symmetrically identical dimensions on both right and left hand sides of the vehicle.

Unit: mm

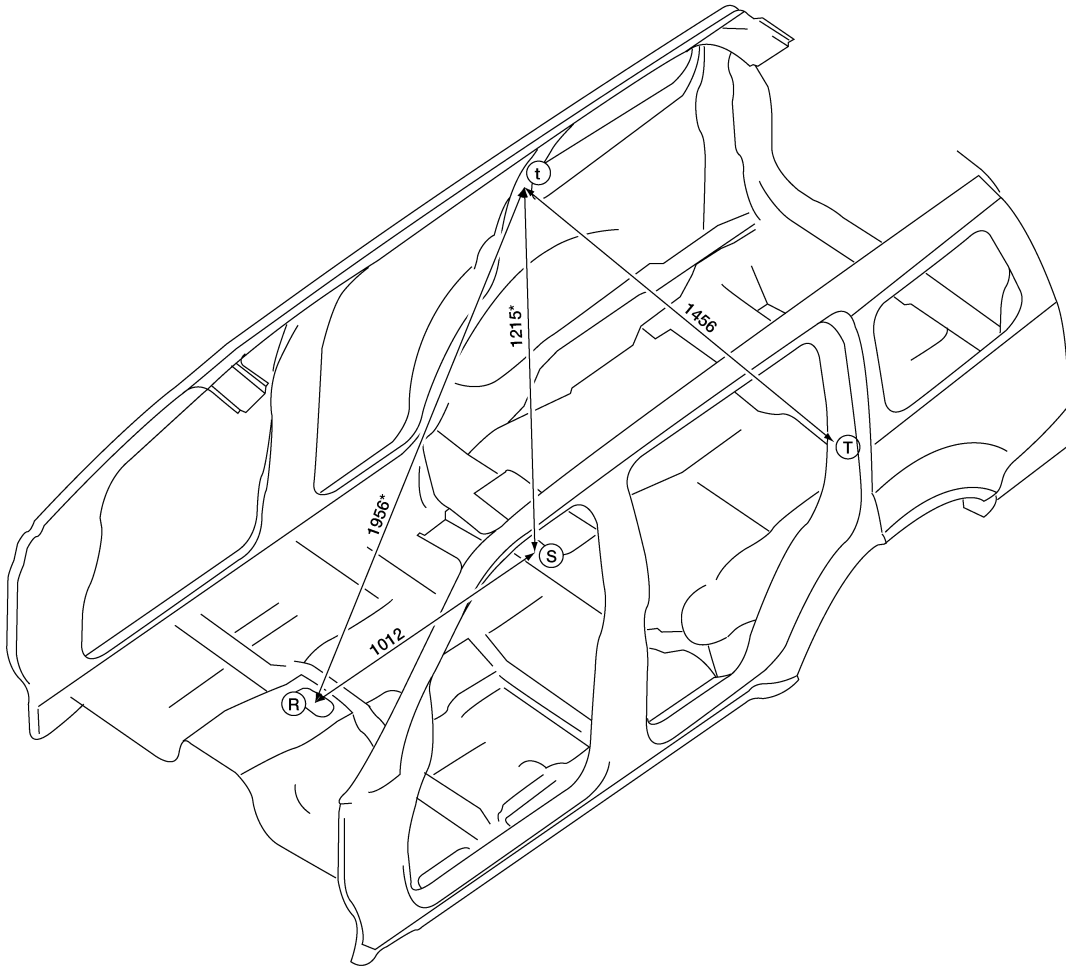
LIA1799E

Figures marked with a (*) indicate symmetrically identical dimensions on both right and left hand sides of the vehicle.

Unit: mm

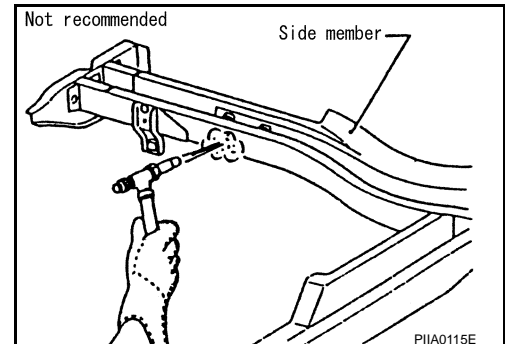
- The repair of reinforcements (such as side members) by heating is not recommended since it may weaken the component. When heating is unavoidable, do not heat HSS parts above 550°C (1,022°F). Verify heating temperature with a thermometer. (Crayon-type and other similar type thermometer are appropriate.)

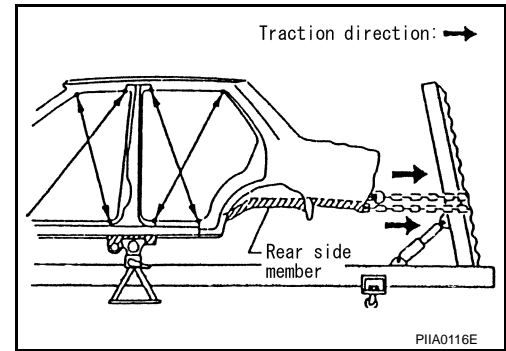
- When straightening body panels, use caution in pulling any HSS panel. Because HSS is very strong, pulling may cause deformation in adjacent portions of the body. In this case, increase the number of measuring points, and carefully pull the HSS panel.

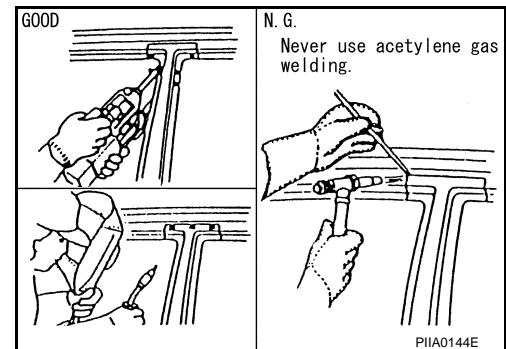
- When welding HSS panels, use spot welding whenever possible in order to minimize weakening surrounding areas due to heat. If spot welding is impossible, use M.I.G. welding. Do not use gas (torch) welding because it is inferior in welding strength.

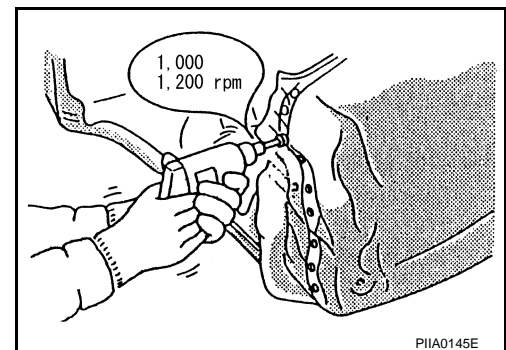
- The spot weld on HSS panels is harder than that of an ordinary steel panel. Therefore, when cutting spot welds on a HSS panel, use a low speed high torque drill (1,000 to 1,200 rpm) to increase drill bit durability and facilitate the operation.
- SP150 HSS panels with a tensile strength of 785 to 981 N/mm² (80 to 100 kg/mm², 114 to 142 klb/sq in), used as reinforcement in the door guard beams, is too strong to repair. When these HSS parts are damaged, the outer panels also sustain substantial damage; therefore, the assembly parts must be replaced.

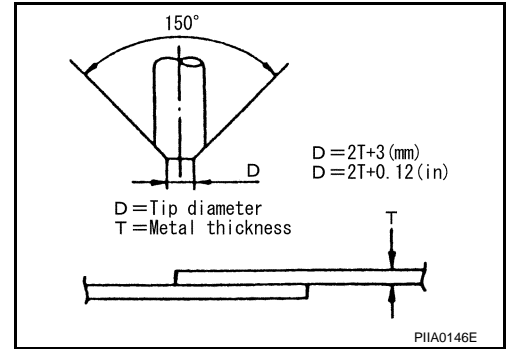
- The electrode tip diameter must be sized properly according to the metal thickness.

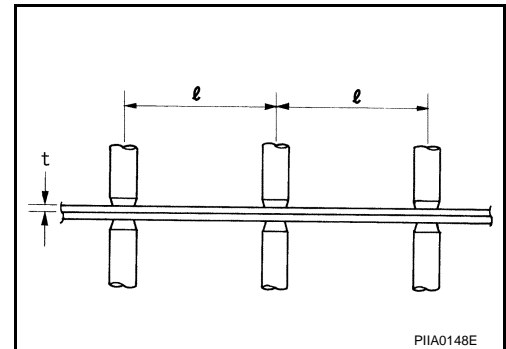
- Follow the specifications for the proper welding pitch.

Thickness (t)	Minimum pitch (ℓ)
0.6 (0.024)	10 (0.39) or over
0.8 (0.031)	12 (0.47) or over
1.0 (0.039)	18 (0.71) or over
1.2 (0.047)	20 (0.79) or over
1.6 (0.063)	27 (1.06) or over
1.8 (0.071)	31 (1.22) or over

Unit:mm

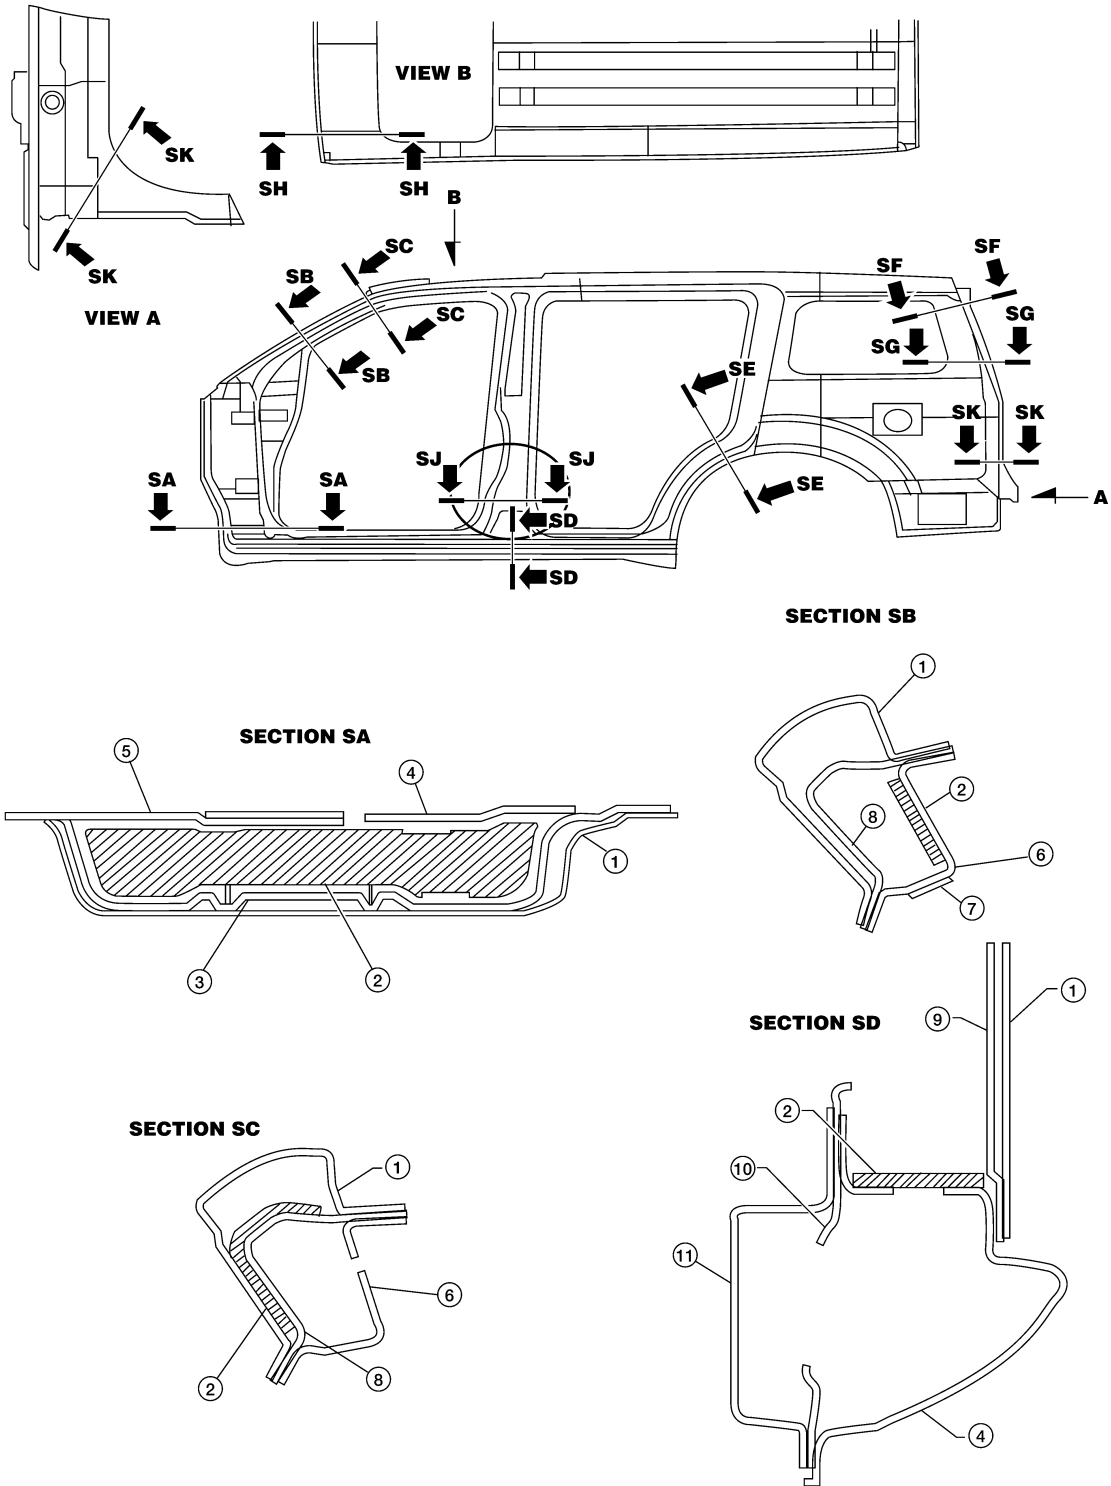
LIA1807E

| 1. Body side outer | 2. Body side insulation (foam) | 3. A-pillar lower hinge brace |
| 4. Sill outer reinforcement | 5. front sill outer reinforcement | 6. Inner A-pillar upper |
| 7. A-pillar inner bracket | 8. A-pillar upper hinge brace | 9. B-pillar hinge brace |
| 10. Inner B-pillar | 11. Inner sill extension | |

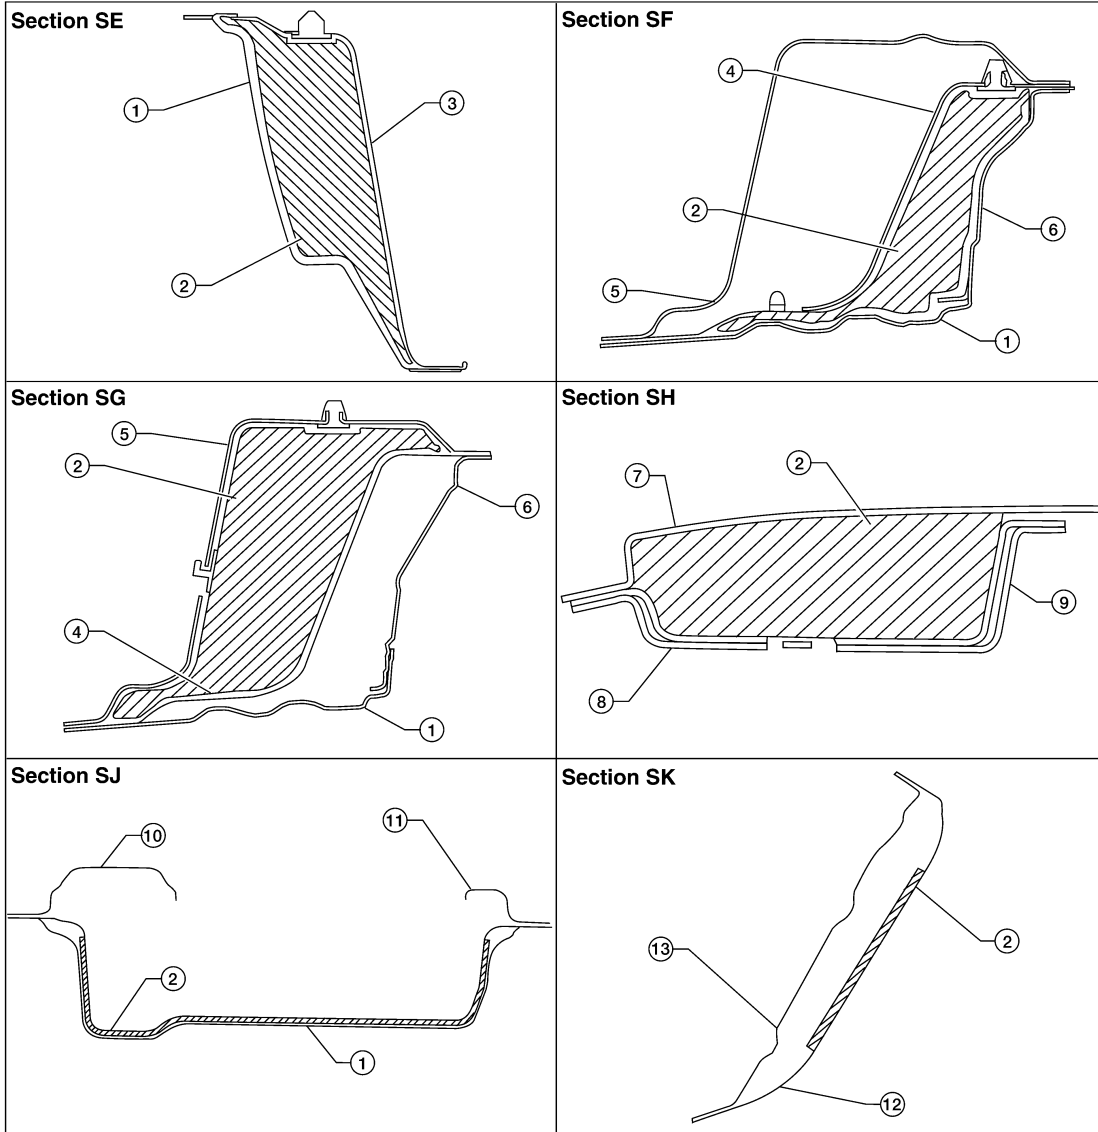
LIA1817E

| 1. Body side outer | 2. Body side insulation (foam) | 3. Rear wheel outer |
| 4. Side panel inner | 5. D-pillar inner reinforcement | 6. D-pillar outer reinforcement |
| 7. Roof | 8. Front roof rail | 9. Front roof rail brace |
| 10. B-pillar inner | 11. B-pillar hinge brace | 12. Rear side inner extension |
| 13. D-pillar mail lower | | |

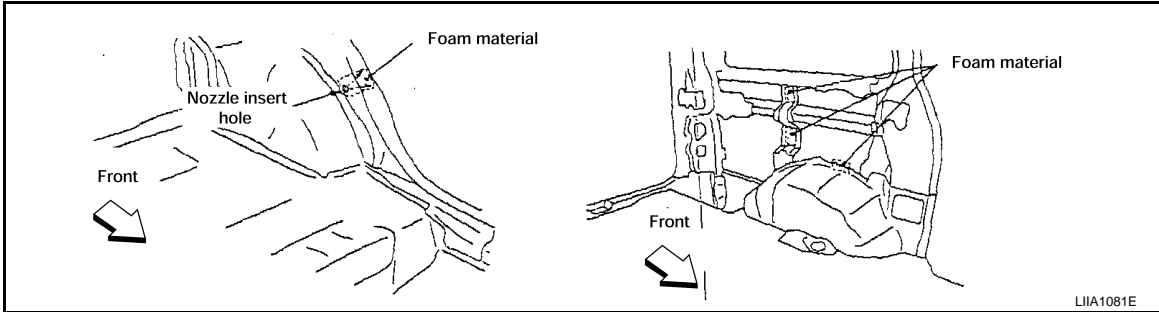
1. Fill procedures after installation of service part.

- Remove foam material remaining on vehicle side.
- Clean area in which foam was removed.
- Install service part.
- Insert nozzle into hole near fill area and fill foam material or fill in enough to close gap with the service part.

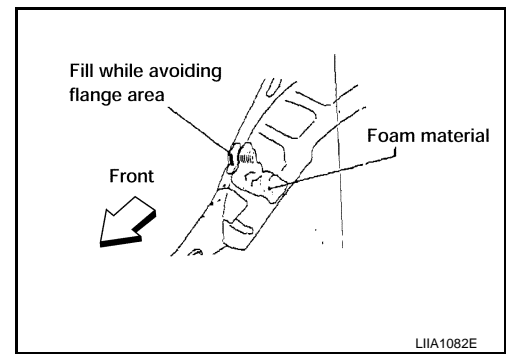
2. Fill procedures before installation of service part.
 - Remove foam material remaining on vehicle side.
 - Clean area in which foam was removed.
 - Fill foam material on wheelhouse outer side.

Fill in enough to close gap with service part while avoiding flange area.

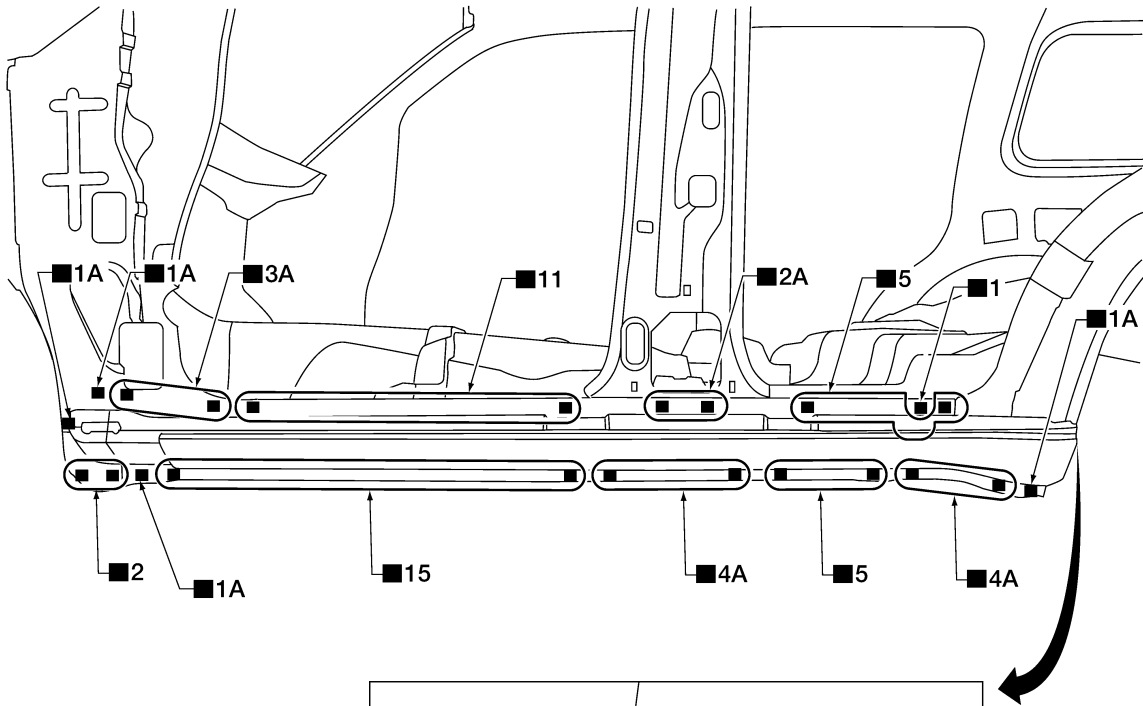
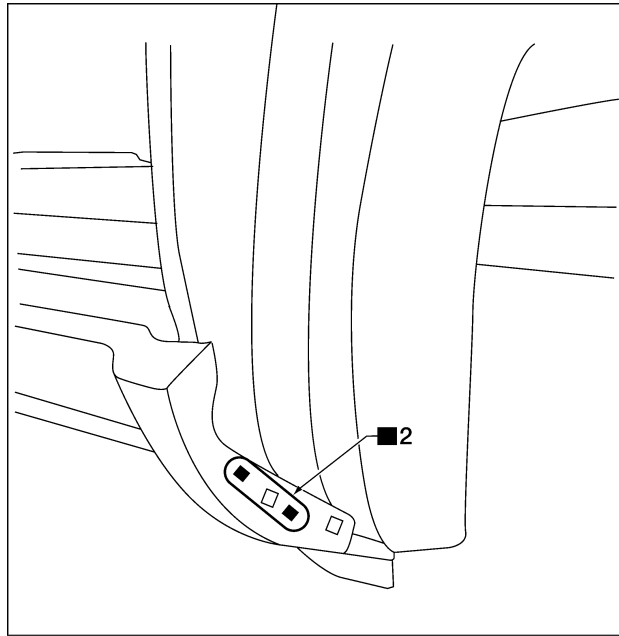
LIA1813E

OUTER SILL

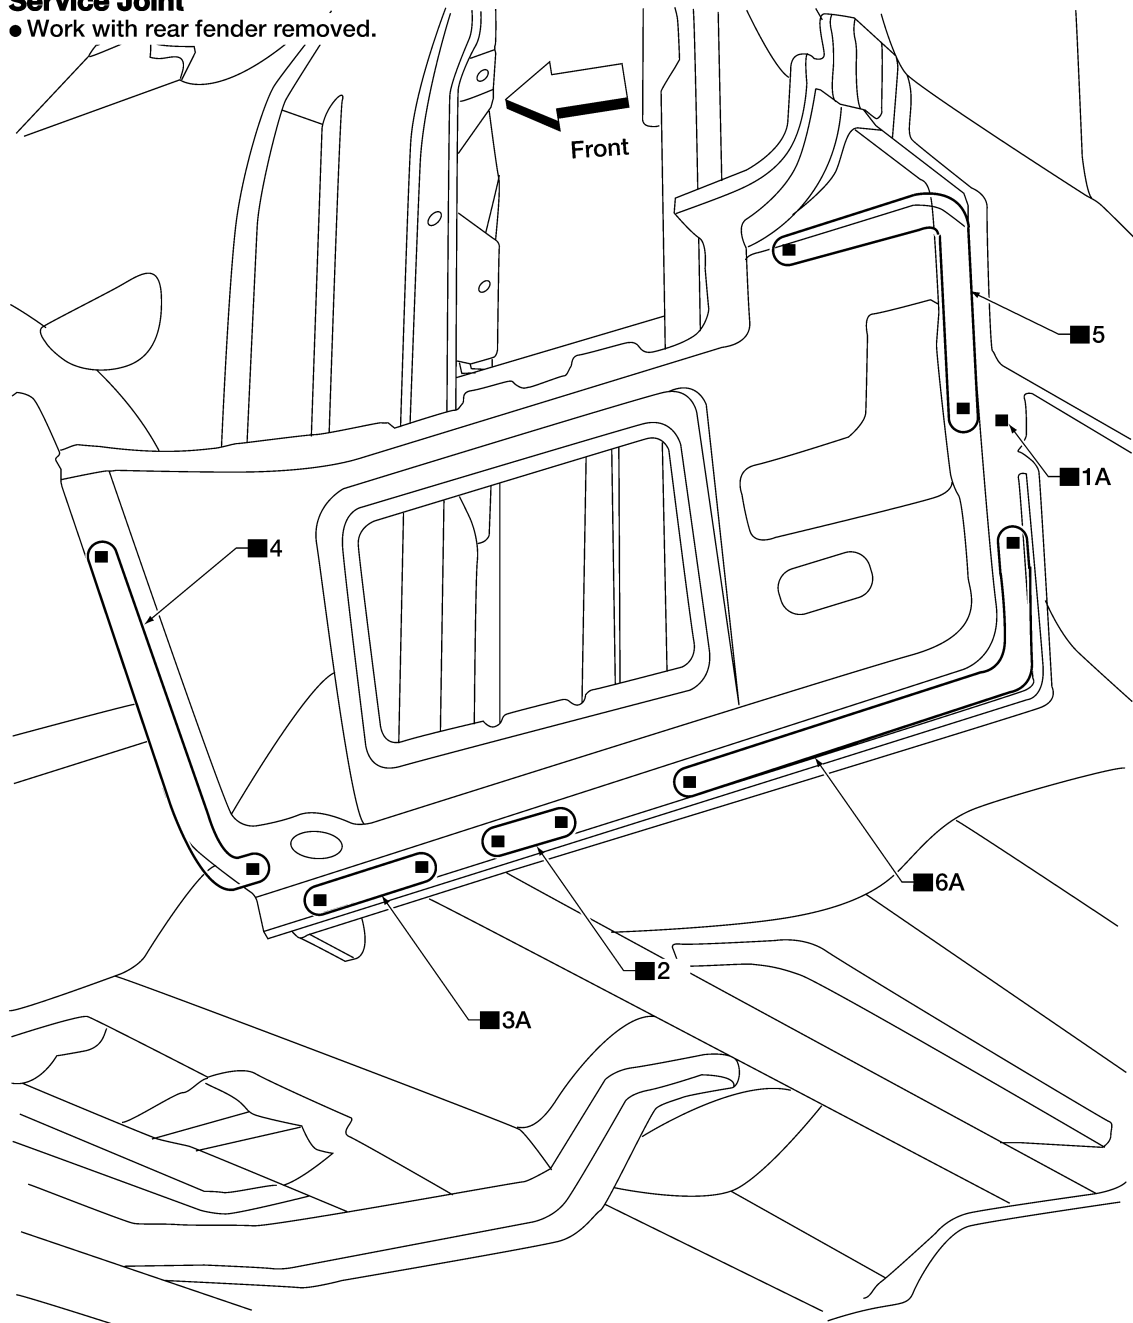
Service Joint

● Work with rear fender removed.

2-spot welds

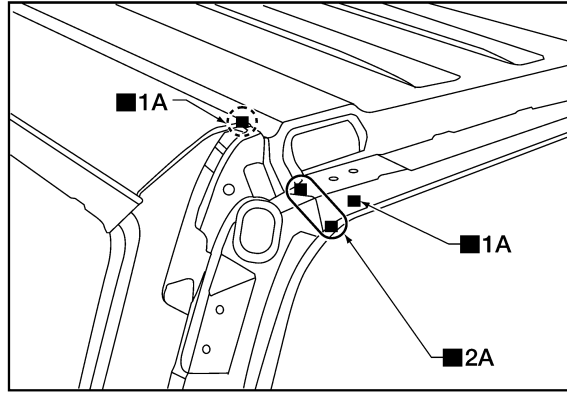
LIA1820E

- Work with rear fender and extension removed.

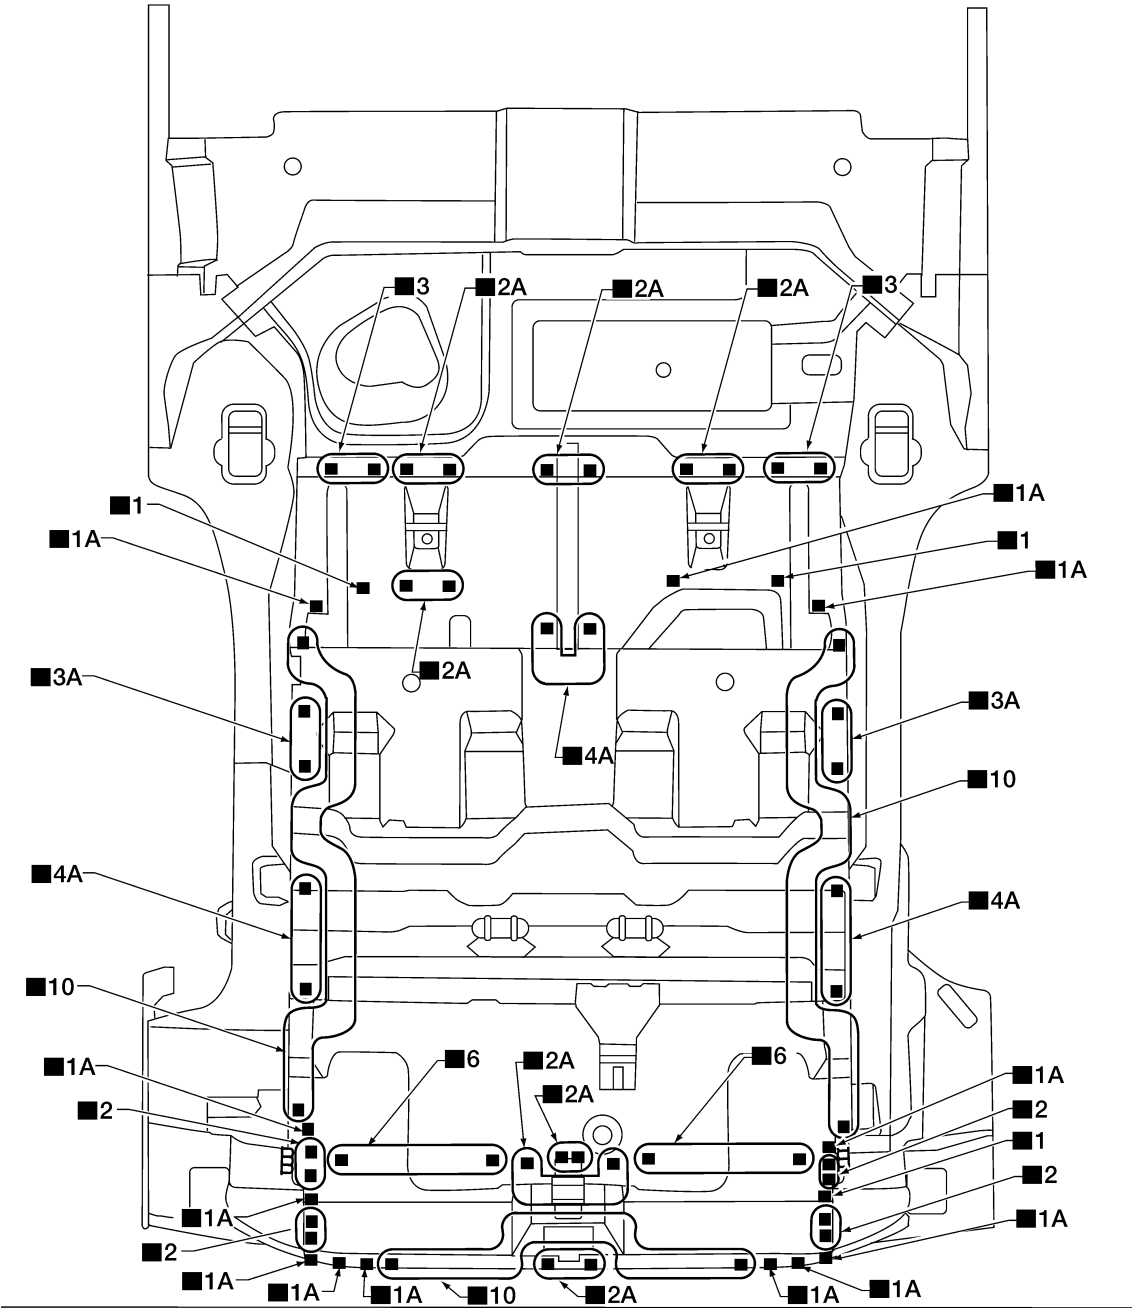
LIA1815E

REAR FLOOR REAR
