SECTION **BRM**
BODY REPAIR

BODY REPAIR

Body Exterior Paint Color

UNDERBODY COMPONENT PARTS

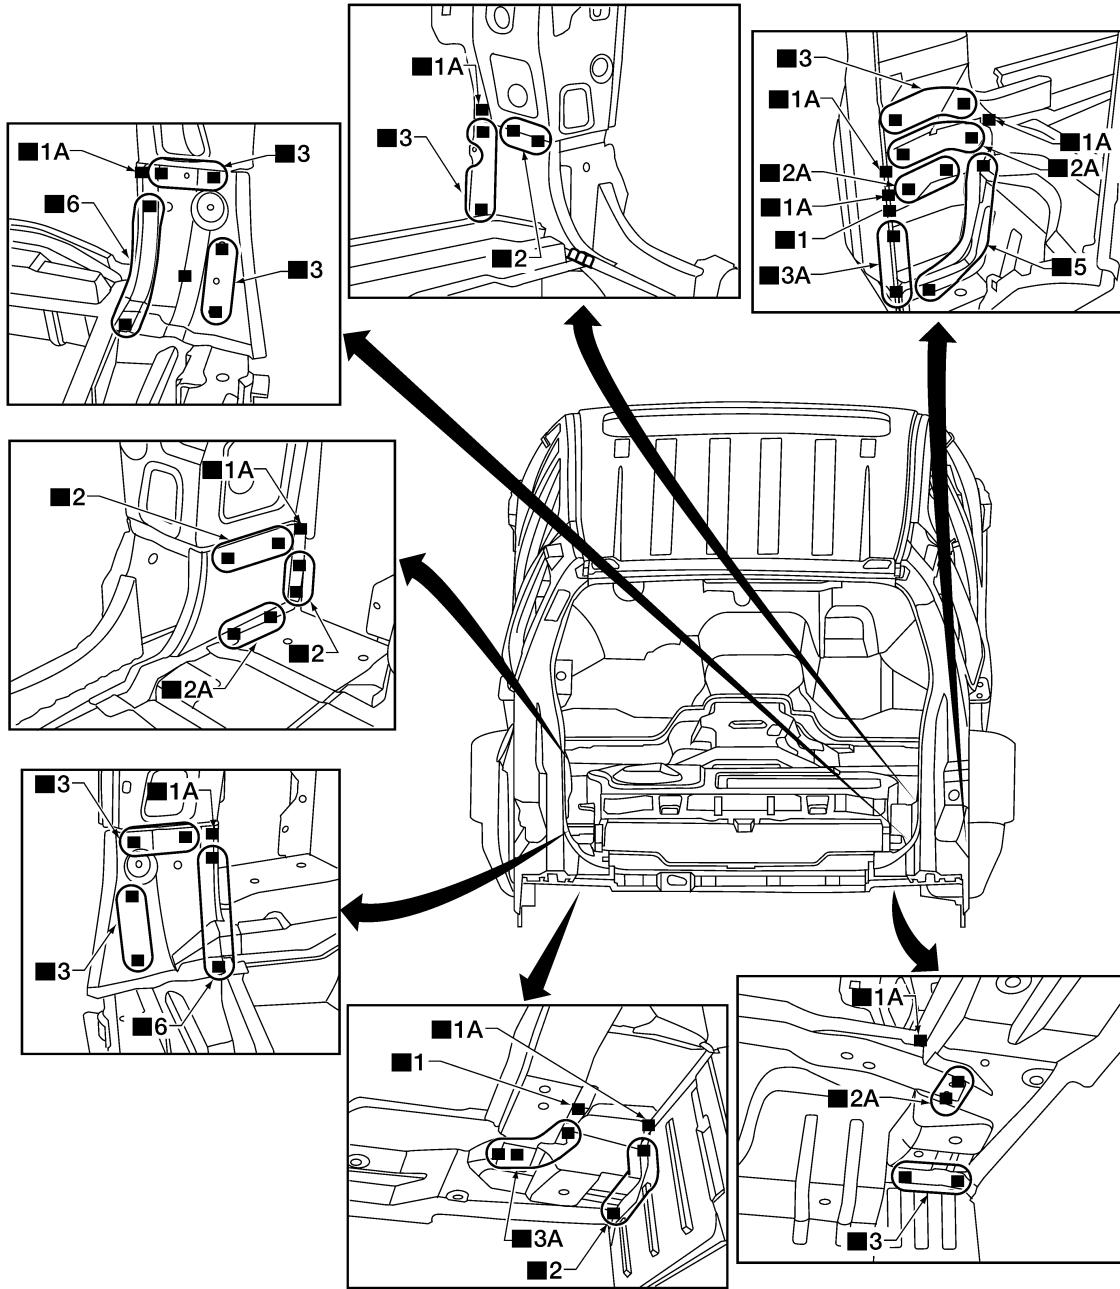
LIA1816E

REAR CROSSMEMBER

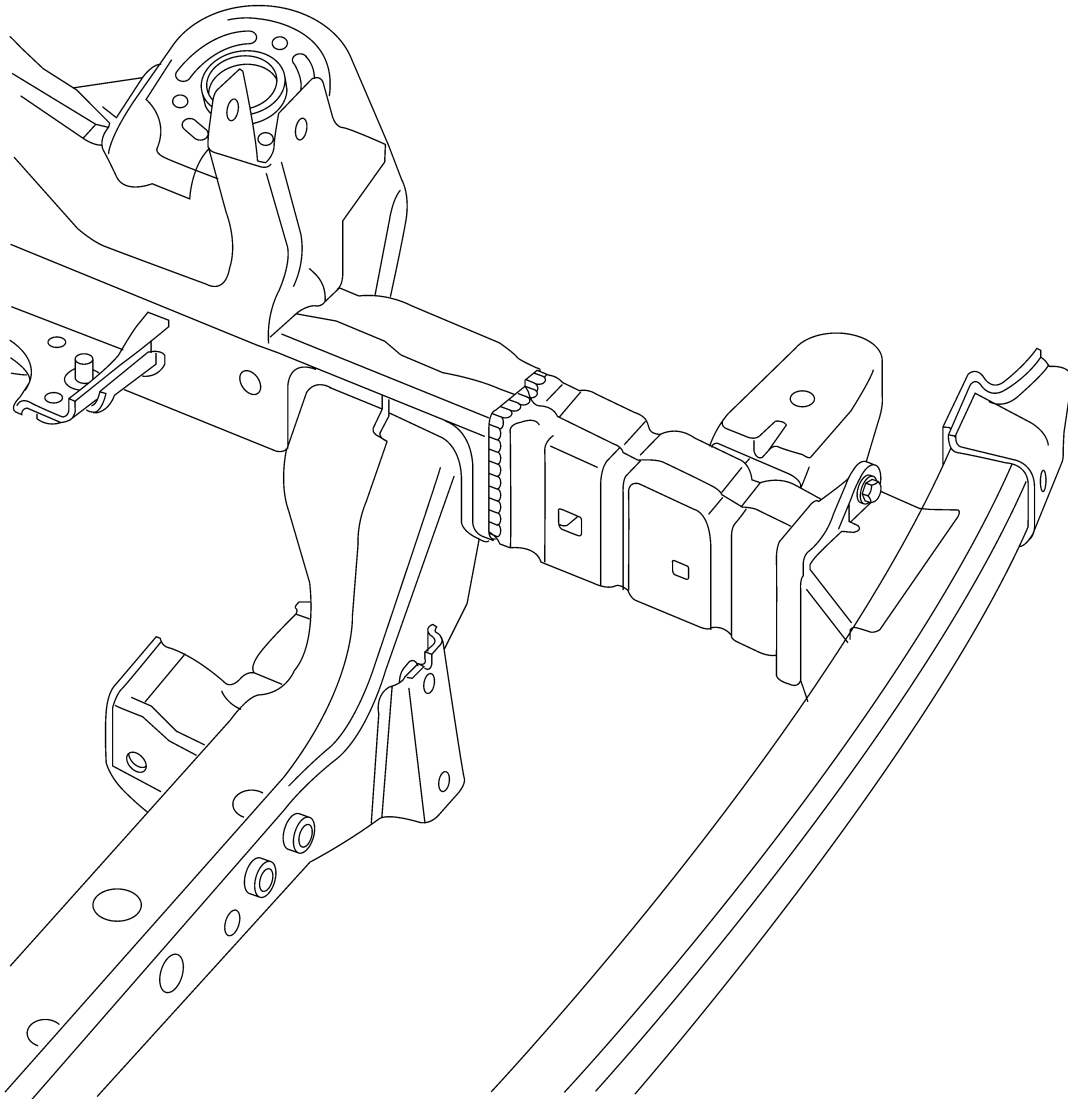
Service Joint

When replacing a damaged crush horn on N50 model, do not choose partial replacement method, such as cutting and butt-joint welding the crush horn.

Be sure to replace the entire crush horn when the crush horn has damage at the back of the body mounting bracket.

2-spot welds
