CONTENTS

BODY FRONT END PFP:H5022 Α Removal and Installation When removing or installing hood, place a cloth or other padding on front fender panels and cowl top. This prevents vehicle body from being scratched. В Bumper fascia is made of plastic. Do not use excessive force and be sure to keep oil away from it. Hood adjustment: Adjust at hinge portion. Hood lock adjustment: After adjusting, check hood lock control operation. Apply a coat of grease to hood lock engaging mechanism. Hood opener: Do not attempt to bend cable forcibly. Doing so increases effort required to unlock hood. D FRONT BUMPER ASSEMBLY 1. Remove screws securing left and right front fog lamps, and remove the lamps (if equipped); or remove filler trim panel. Е Remove four clips C205 from the top of the front grille, pull up to unclip bottom and remove. A 3. Remove clips C205 and screws located on front side of fender protector at wheel opening. F Remove three bolts from the air deflector. 4. 5. Remove two bolts securing lower side of front bumper fascia. 6. Pull off front bumper fascia and energy absorber. 7. Remove four nuts securing bumper reinforcement, then remove bumper reinforcement. Remove four bolts securi

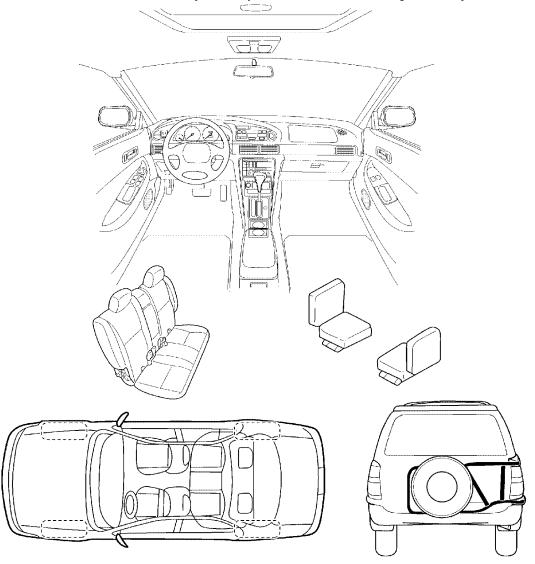
SQUEAK & RATTLE DIAGNOSTIC WORKSHEET

I. WHERE DOES THE NOISE COME FROM? (circle the area of the vehicle)

The illustrations are for reference only, and may not reflect the actual configuration of your vehicle.

Continue to the back of the worksheet and briefly describe the location of the noise or rattle. In addition, please indicate the conditions which are present when the noise occurs.

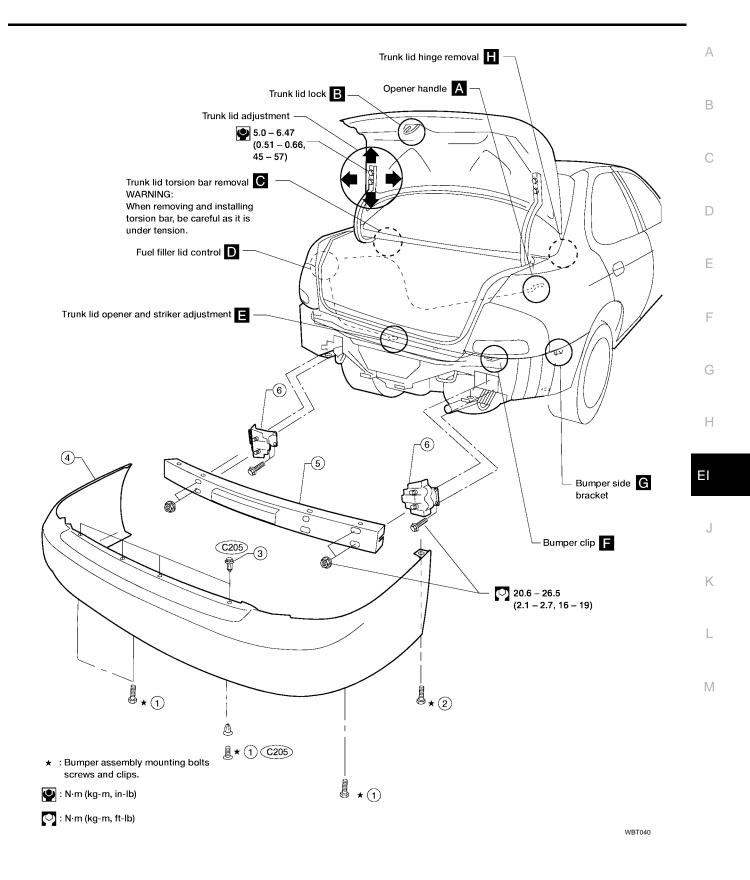
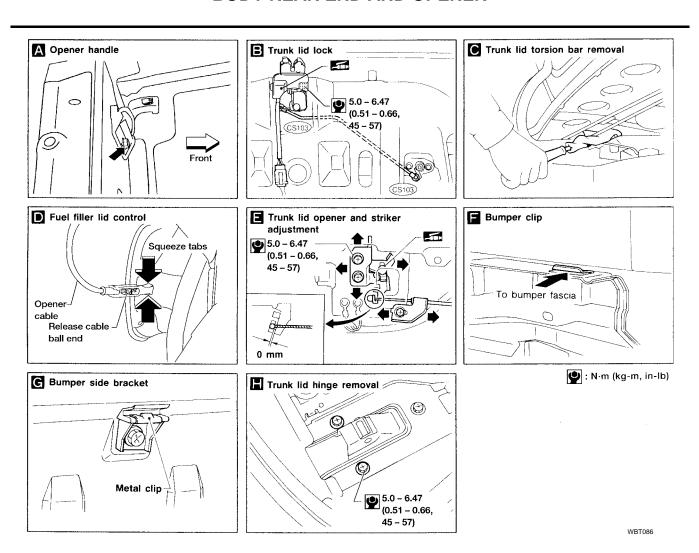
REAR BUMPER ASSEMBLY

- 1. Remove four bolts and one clip C205 from lower side of rear bumper fascia.
- 2. Remove two screws from each quarter panel side.
- 3. Remove four clips C205 from upper side of rear bumper fascia.
- 4. Remove rear bumper fascia.
- 5. Remove four nuts securing bumper reinforcement, then remove bumper reinforcement.
- 6. Remove four bolts securing bumper side stays, then remove bumper side stays.

- Bumper fascia is made of plastic. Do not use excessive force and be sure to keep oil away from it.
- Trunk lid adjustment: Adjust at hinge-trunk lid portion for proper trunk lid fit.
- Trunk lid lock system adjustment: Adjust striker so that it is in the center of the lock. After adjustment, check trunk lid lock operation.
- Opener cable: Do not attempt to bend cable using excessive force.
- After installation, make sure that trunk lid and fuel filler lid open smoothly.

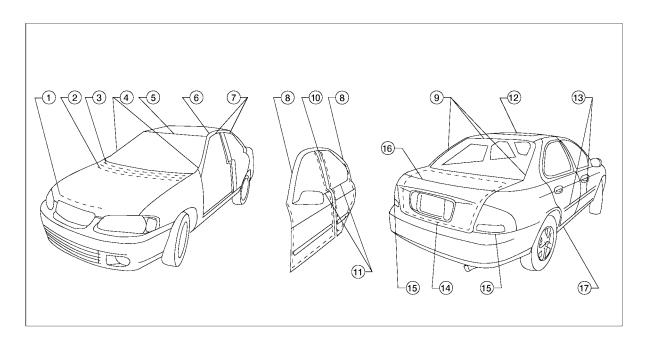
1 Hood front seal

2 3 Cowl top seal and cowl top grille

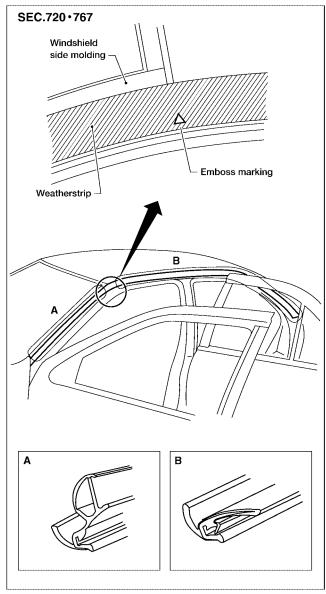
6 Drip weatherstrip

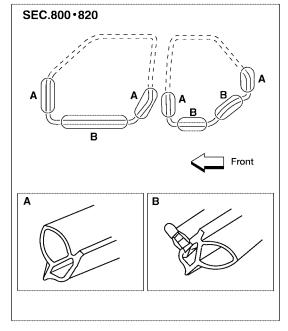
8 Door weatherstrip

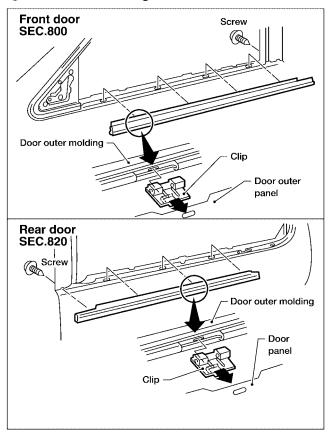
11 Door outside molding

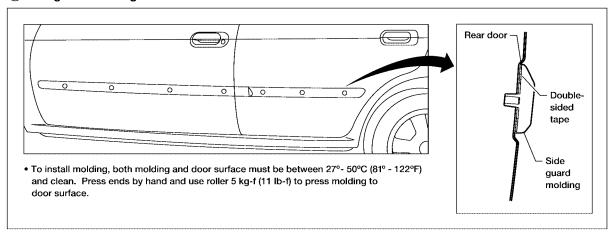
12 Sunroof lid weatherstrip

Sunroof weatherstrip is part of the glass lid and must be replaced as an assembly.

13 Side guard molding

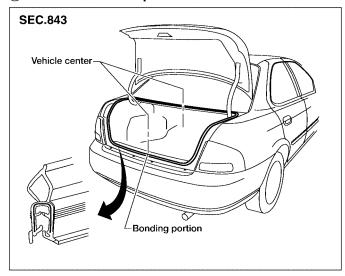
14 Trunk lid weatherstrip

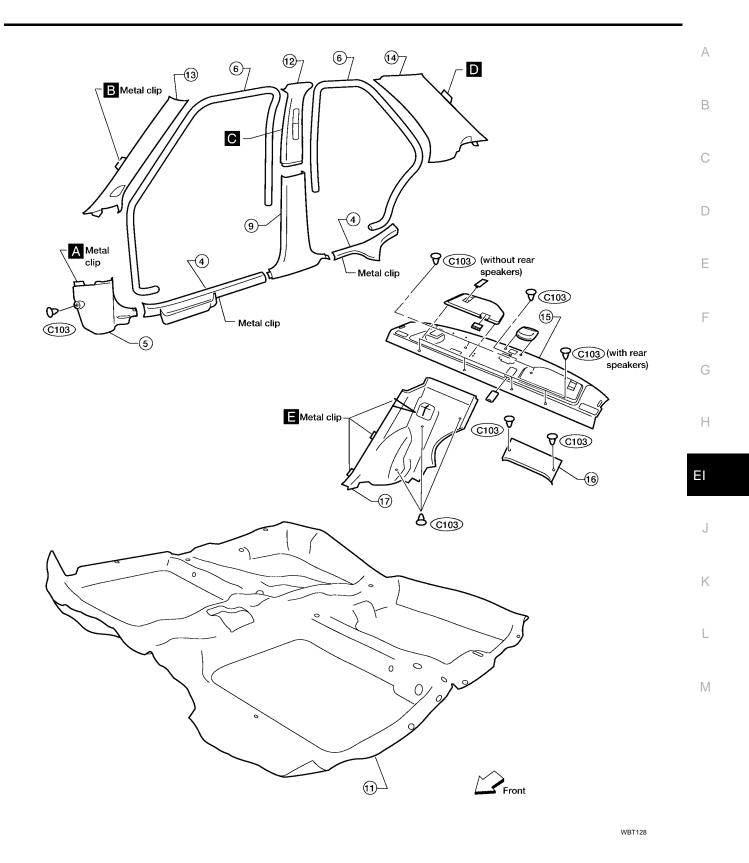
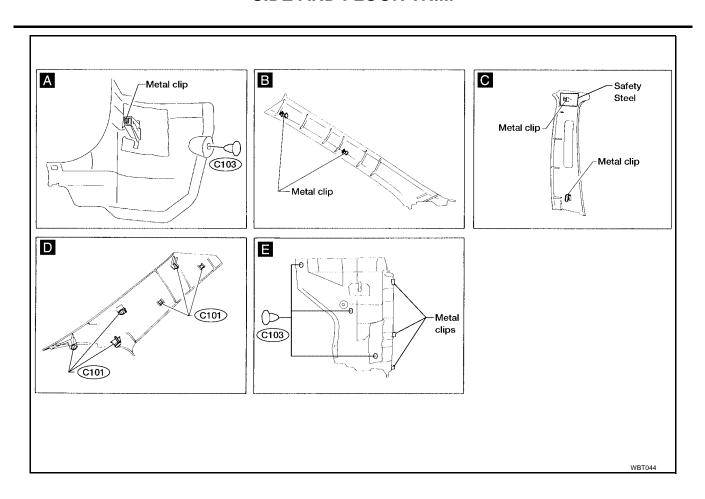
- Wrap the tip of flat-bladed screwdriver with a cloth when removing metal clips from garnishes.
- 1. Remove A/T finisher or M/T shift lever boot. Refer to IP-10, "Removal and Installation".

- 2. Remove the console. Refer to IP-10, "Removal and Installation".
- 3. Remove front and rear seats. Refer to <u>SE-3, "Removal and Installation"</u> (front), or <u>SE-5, "Removal and Installation"</u> (rear).

- 4. Remove kick plates.
- 5. Remove dash side lower garnish. A
- 6. Remove body side welts.
- 7. Remove front seat belt floor anchor bolt. Refer to SB-3, "Removal and Installation".

- 8. Remove rear seat belt floor anchor bolt. Refer to SB-5, "Removal and Installation".
- 9. Remove center pillar lower garnish.
- 10. Remove adjuster cover and pillar shoulder bolt. Refer to SB-3, "Removal and Installation".

- 11. Remove floor carpet.
- 12. Remove center pillar upper garnish.
- 13. Remove front pillar garnish.
- 14. Remove rear pillar garnish.
- 15. Remove parcel shelf.

- 16. Remove center rear seat back finisher.
- 17. Remove side rear seat back finishers.

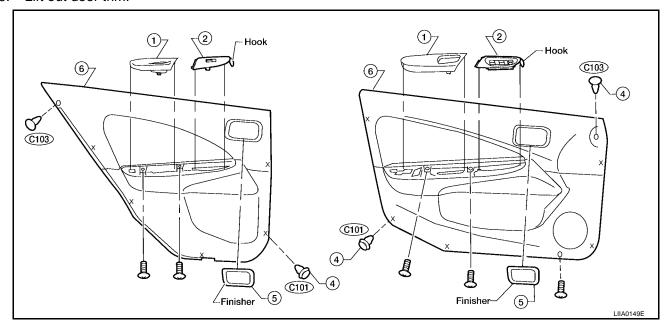
Wrap the tip of a flat-bladed screwdriver with cloth when prying pawls from door trim.

- 1. Remove the door pull finisher(s).
- 2. Remove power window switch(es) finisher(s), then disconnect the connector(s) (models equipped with power windows).
- Do not lift the front of the power window switch assembly.
- 3. Remove window regulator handle (models without power windows).
- 4. Remove screws and disconnect clips C101 and clips C103 from door.
- 5. Reach behind and carefully pull door trim panel from inside handle until finisher pops off.
- 6. Lift out door trim.

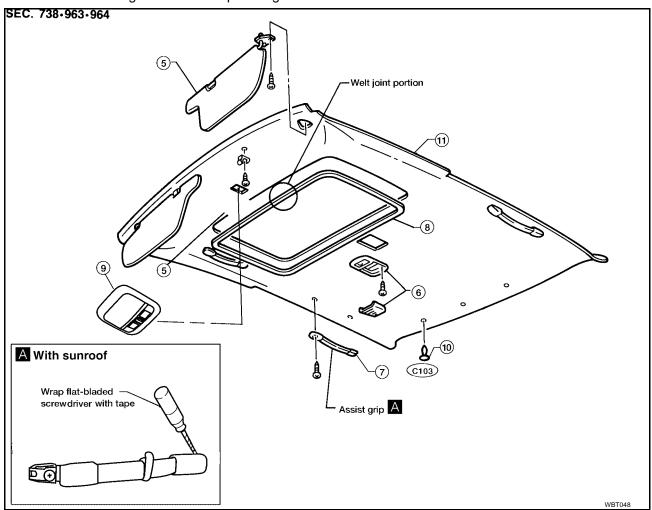
Disconnect both terminals from battery in advance.

- 1. Remove driver air bag module and steering wheel. Refer to <u>SRS-40, "Removal and Installation"</u> and <u>PS-11, "STEERING WHEEL"</u>.
- 2. Fully tilt front right and left seat backs backward.
- 3. Remove front pillar garnish, front and rear kick plates. Refer to El-28, "Removal and Installation".
- 4. Remove center pillar lower and upper garnish, and rear pillar garnish. Refer to El-28, "Removal and Installation".
- 5. Remove sun visors.
- 6. Remove interior lamp.
- 7. Remove assist grips (if equipped). A
- 8. Remove sunroof welt (if equipped) and door welts.
- 9. Remove sunroof switch (if equipped) and map lamp assembly.
- 10. Remove clips attached to roof.
- 11. Take out headlining from the front passenger door.
