SQUEAK AND RATTLE TROUBLE DIAGNOSES

INSTRUMENT PANEL ASSEMBLY

Revision: June 2006 IP-11 2007 Versa

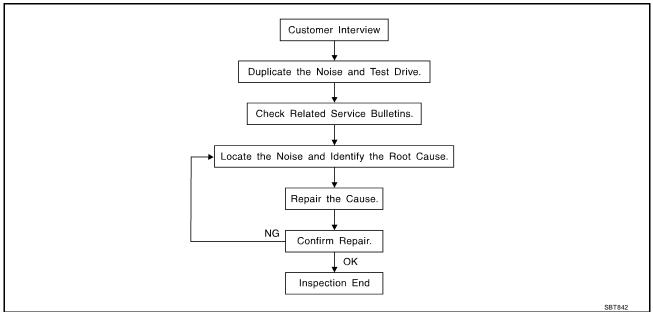
Work Flow

CUSTOMER INTERVIEW

DUPLICATE THE NOISE AND TEST DRIVE

LOCATE THE NOISE AND IDENTIFY THE ROOT CAUSE

REPAIR THE CAUSE

CONFIRM THE REPAIR

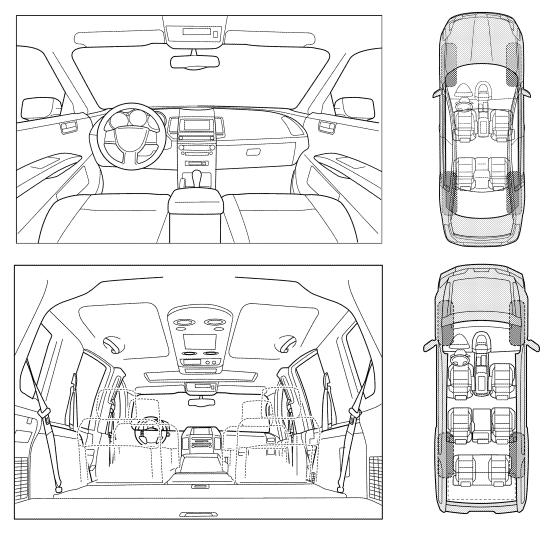
SQUEAK & RATTLE DIAGNOSTIC WORKSHEET

I. WHERE DOES THE NOISE COME FROM? (circle the area of the vehicle)

The illustrations are for reference only, and may not reflect the actual configuration of your vehicle.

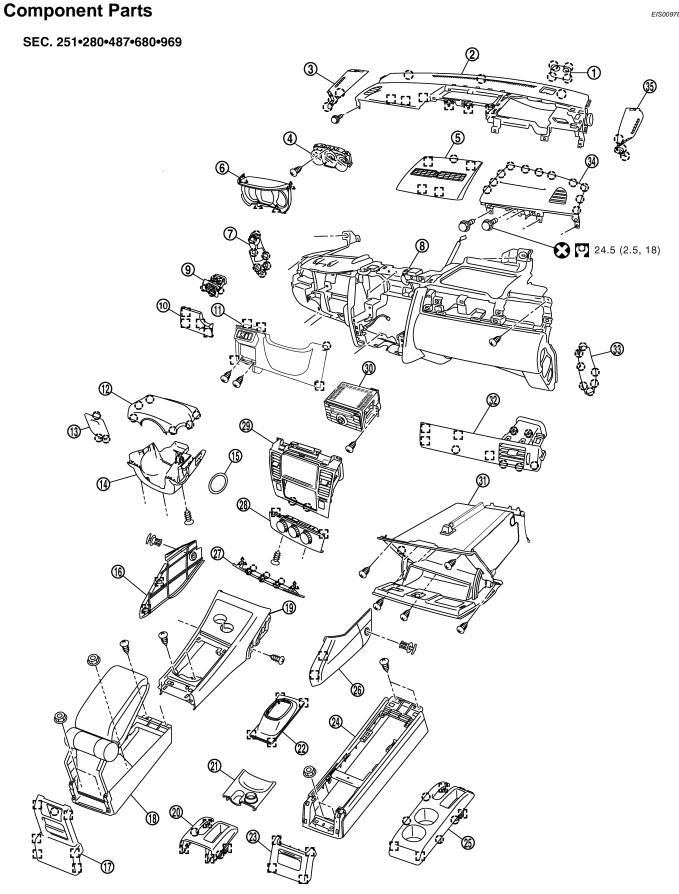
1.	Instrument upper mask	2.	Instrument upper panel assembly	3.	Instrument side panel (LH)	
4.	Combination meter	5.	Instrument finisher E	6.	Cluster lid A	ı

7.	Instrument side mask (LH)	8.	Instrument panel & pad	9.	Side ventilator assembly (LH)	
10.	Instrument side finisher	11.	Instrument lower finisher	12.	Steering column cover upper

13.	Fuse block lid	14.	Steering column cover lower	15.	Steering lock escutcheon	
16.	Instrument lower cover (LH)	17.	Console rear finisher (with armrest)	18.	Console body assembly (with arm-rest)

19.	Center console	20.	Console mask cover (with armrest)	21.	Console mask	
22.	A/T console finisher / M/T console boot / CVT console finisher	23.	Console rear finisher (without armrest)	24.	Console body assembly (without armrest)

25.	Rear cup holder (without armrest)	26.	Instrument lower cover (RH)	27.	Instrument finisher D	
28.	Controller	29.	Cluster lid C	30.	Audio unit	
31.	Glove box assembly	32.	Side ventilator assembly (RH)	33.	Instrument side mask (RH)

34.	Passenger air bag module assembly	35.	Instrument side panel (RH)	(_)	Pawl	
<u>^</u> _>	Clip	[]	Metal clip			
Don	noval and Installation

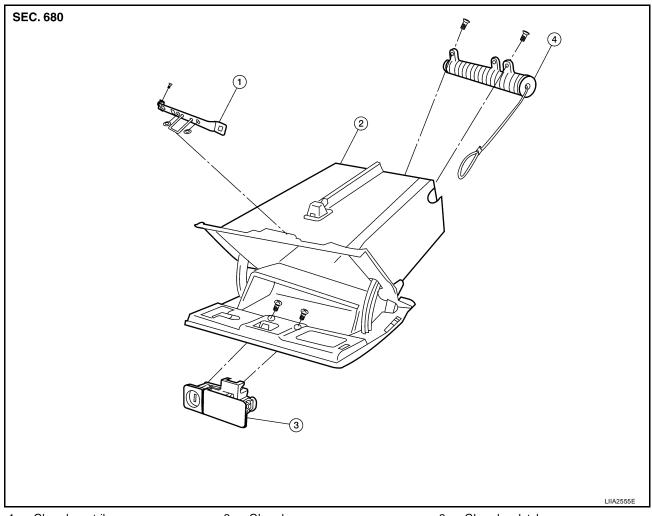
Disassembly and Assembly GLOVE BOX ASSEMBLY

- Glove box striker
- 2. Glove box

3. Glove box latch

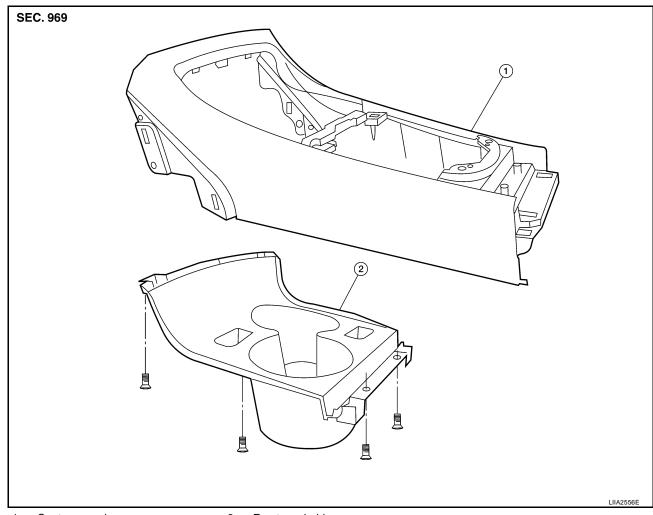
CENTER CONSOLE ASSEMBLY

Center console

2. Front cup holder
