BODY

SECTION RF ROOF

Component Parts and Harness Connector Location

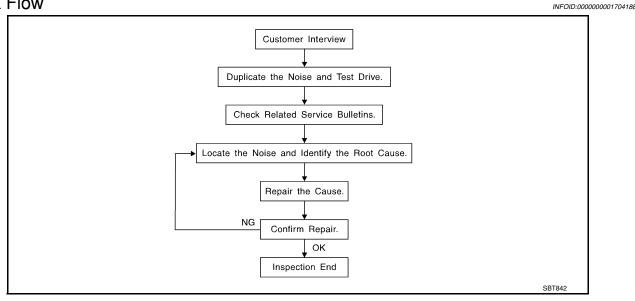
Work Flow

CUSTOMER INTERVIEW

Interview the customer if possible, to determine the conditions that exist when the noise occurs. Use the Diagnostic Worksheet during the interview to document the facts and conditions when the noise occurs and any customer's comments; refer to <u>IP-8</u>. "Diagnostic Worksheet". This information is necessary to duplicate the conditions that exist when the noise occurs.

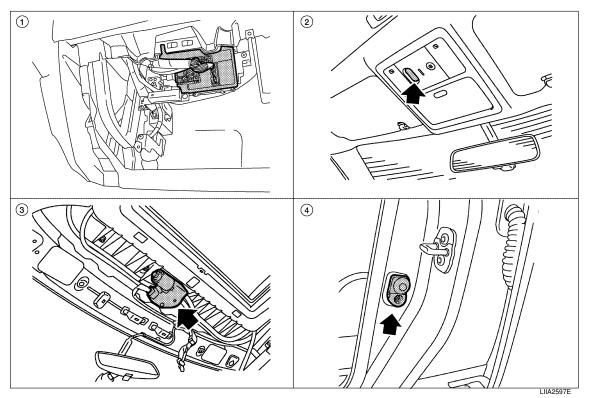
- 1. BCM M18, M19, M20 (view with glove 2. Sunroof switch R6 box removed)
- 4. Front door switch LH B8, RH B108

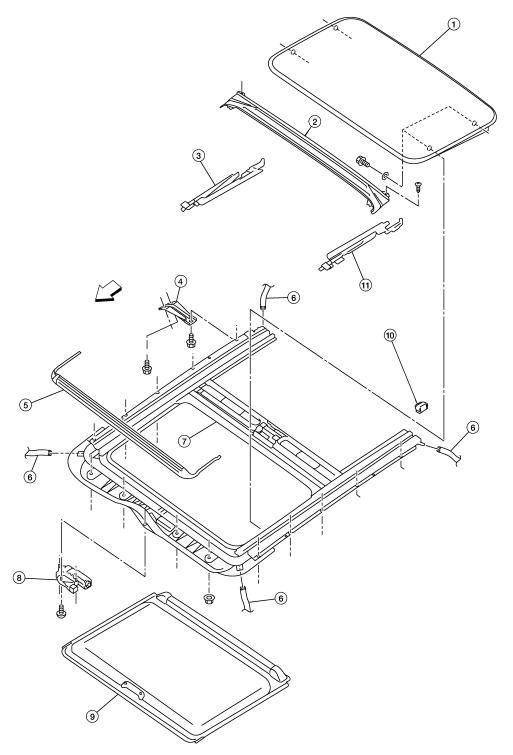
SEC. 736

- 1. Glass lid
- 4. Sunroof bracket
- Sunroof unit assembly
 Sunshade stopper
- Rear drain assembly
 Wind deflector

- 8. Sunroof motor assembly
 - 11. Link assembly (LH)

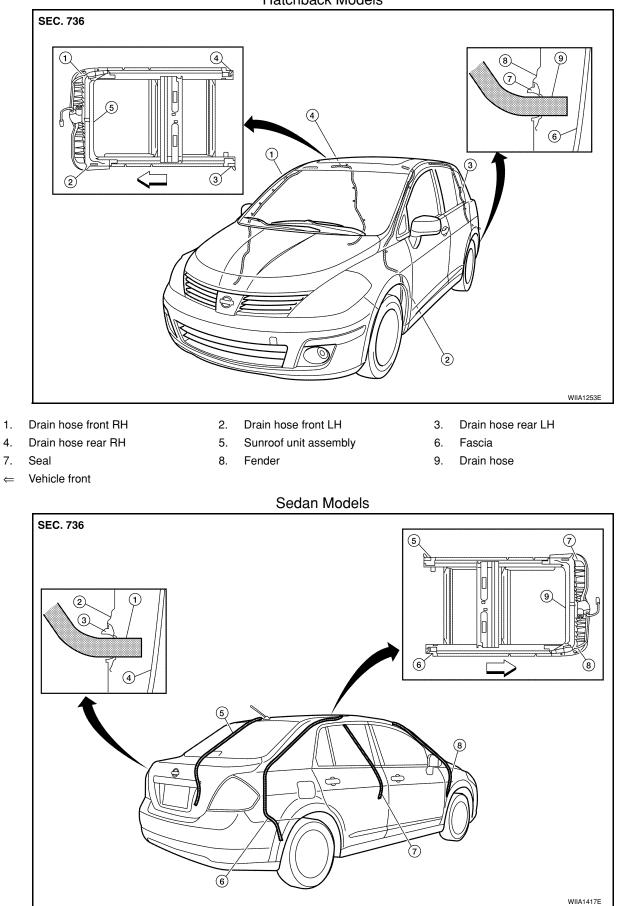
Hatchback Models

1.	Drain hose	2.	Fender	3.	Seal	А
	4.	Fascia	5.	Drain hose rear LH	6.	Drain hose rear RH	
	7.	Drain hose front LH	8.	Drain hose front RH	9.	Sunroof unit assembly	
1		Vehicle front emove headlining. Refer to <u>El-</u>	<u>45. "</u>	Component".			В
2	•	isually check drain hoses for: Proper connection at sunroof u Damage, pinch, cracks, deteric Proper fastening and routing o	oratio	on.			С
З If	. P	our water through drain hoses t maged or leaking portion in an	o de	etermine watertight performanc		ain hose as an assembly.	D
							E
							F
