SECTION **PR**
PROPELLER SHAFT

FRONT PROPELLER SHAFT

REAR PROPELLER SHAFT

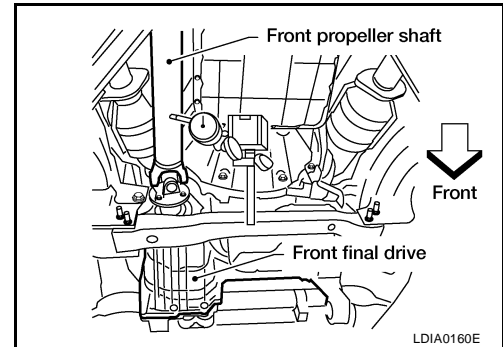
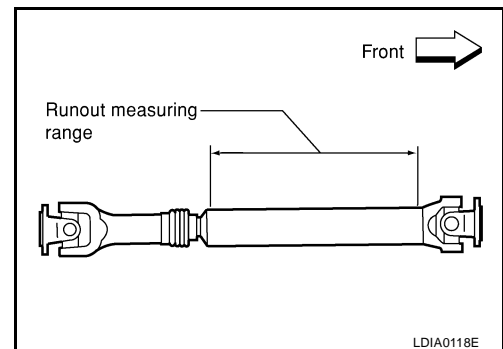
1. Measure the runout of the propeller shaft tube at several points by rotating the final drive companion flange with your hands.

Propeller shaft runout limit : 0.6 mm (0.024 in) or less

2. If the runout exceeds specifications, disconnect the propeller shaft at the final drive companion flange; then rotate the companion flange 90°, 180° and 270° and reconnect the propeller shaft.
3. Check the runout again. If the runout still exceeds specifications, replace the propeller shaft assembly.
4. After installation, check for vibration by driving the vehicle.

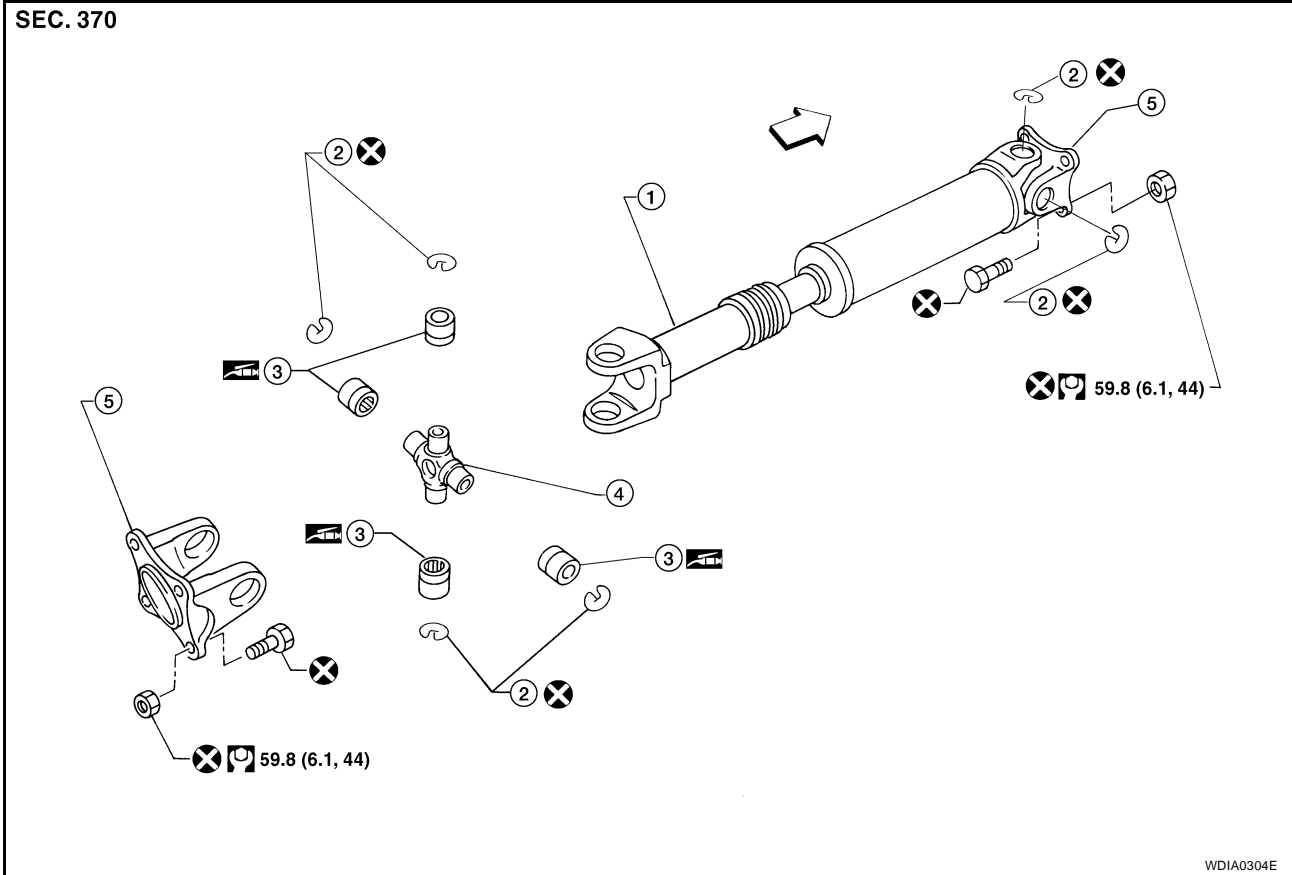
Model 2F1310

| 1. Propeller shaft tube | 2. Snap ring | 3. Journal bearing |
| 4. Journal | 5. Flange yoke | ⇐: Vehicle front |

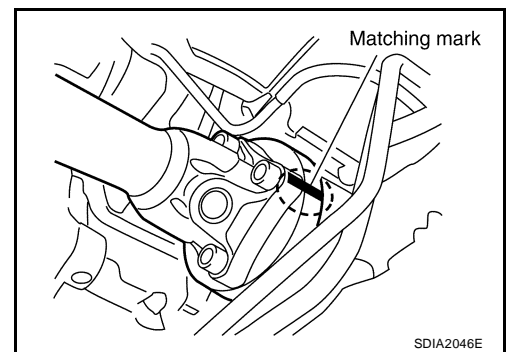
1. Remove the undercover using power tool.
2. Put matching marks on the front propeller shaft flange yoke and the front final drive companion flange as shown.

3. Put matching marks on the front propeller shaft flange yoke and the transfer companion flange.

4. Remove the bolts and then remove the front propeller shaft from the front final drive and transfer.

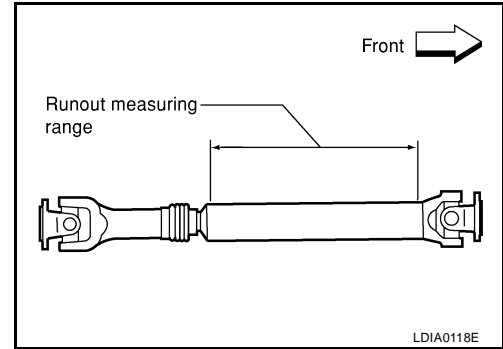
- Inspect the propeller shaft runout. If runout exceeds the limit, replace the propeller shaft assembly.

Runout limit : 0.6 mm (0.024 in) or less

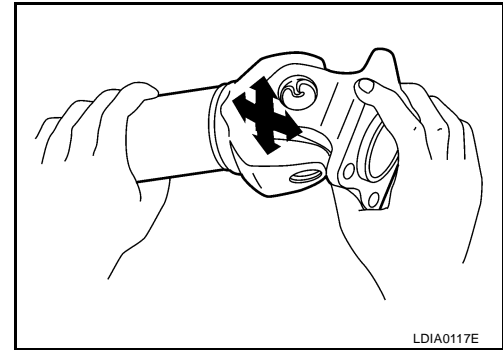
- While holding the flange yoke on one side, check axial play of the joint as shown. If the journal axial play exceeds the specification, repair or replace the journal parts.

Journal axial play : 0.02 mm (0.0008 in) or less

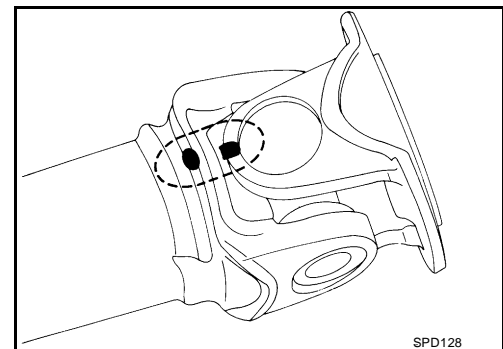
1. Put matching marks on the front propeller shaft and flange yoke as shown.

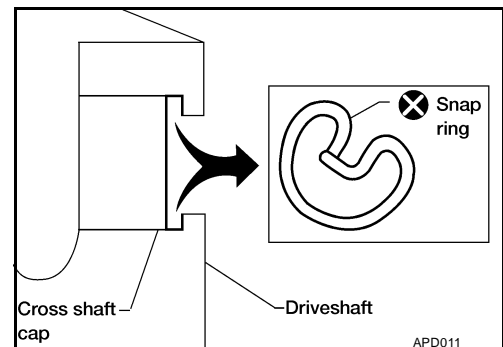
2. Remove the snap rings.

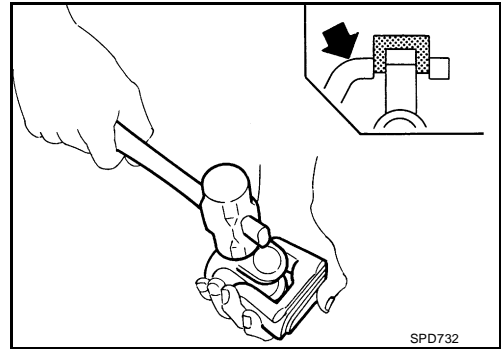
3. Push out and remove the journal bearings by lightly tapping the flange yoke with a hammer, taking care not to damage the journal or flange yoke hole.

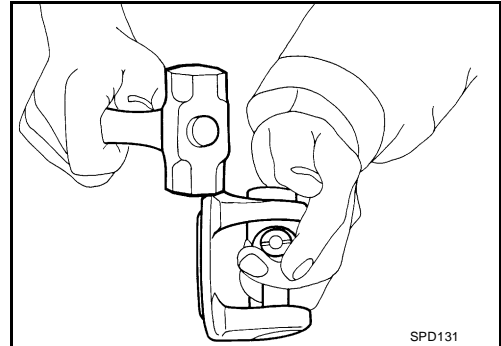
4. Push out and remove the remaining journal bearings at the opposite side by lightly tapping the flange yoke with a hammer, taking care not to damage the journal or flange yoke hole.

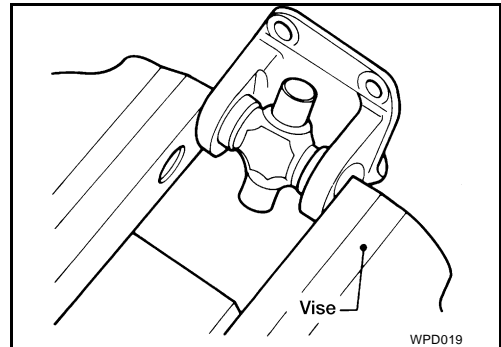
1. Assemble the journal bearings. Apply multipurpose grease on the bearing inner surface.

During assembly, use caution so that the needle bearings do not fall down.

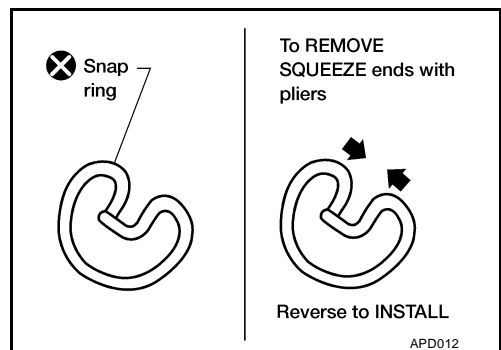
2. Select snap rings that will provide the specified play in an axial direction of the journal, and install them. Refer to [PR-16, "Snap Ring"](#).

Select snap rings with a difference in thickness at both sides within 0.02 mm (0.0008 in).

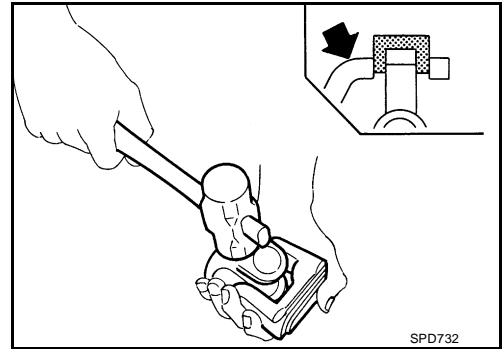
3. Adjust the thrust clearance between the bearing and snap ring to zero by tapping the yoke.

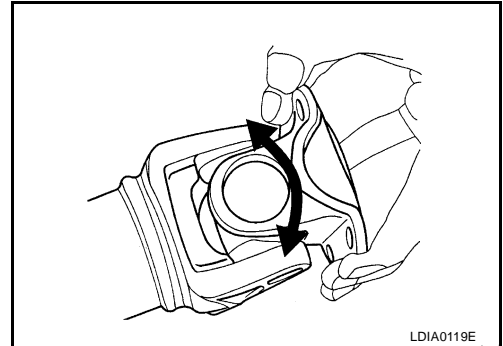
4. Make sure that the journal moves smoothly and is below the joint flex effort specification.

Joint flex effort : 1.96 N·m (0.20 kg·m, 17 in·lb) or less

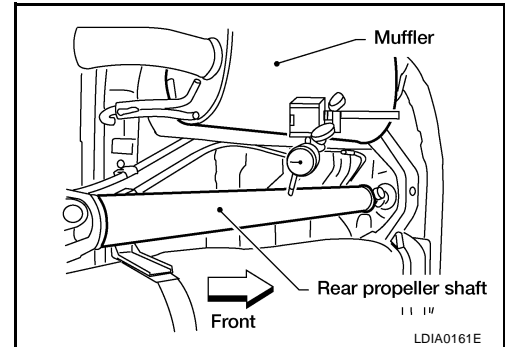
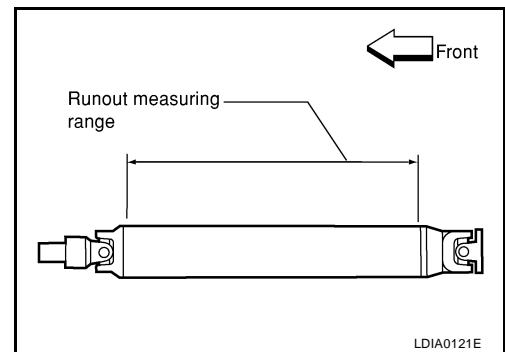
1. Measure the runout of the propeller shaft tube at several points by rotating the final drive companion flange with your hands.

Propeller shaft runout limit

2WD : 1.02 mm (0.040 in) or less

4WD : 0.6 mm (0.024 in) or less

2. If the runout exceeds specifications, disconnect the propeller shaft at the final drive companion flange; then rotate the companion flange 90°, 180° and 270° and reconnect the propeller shaft.
3. Check the runout again. If the runout still exceeds specifications, replace the propeller shaft assembly.
4. After installation, check for vibration by driving vehicle.

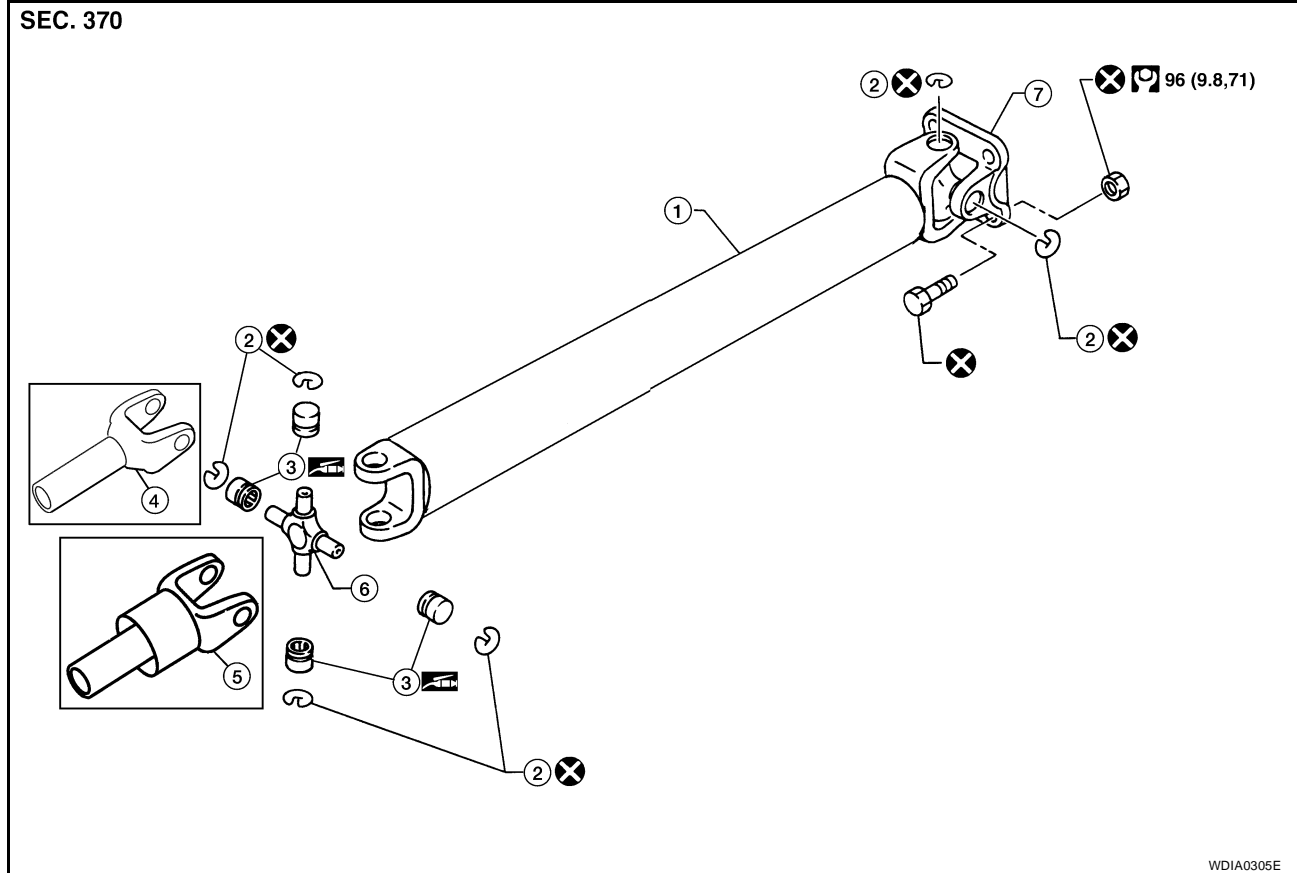
Model 2S1330

| 1. Propeller shaft | 2. Snap ring | 3. Journal bearing |
| 4. Sleeve yoke (M/T models) | 5. Sleeve yoke (A/T models) | 6. Journal |
| 7. Flange yoke | | |

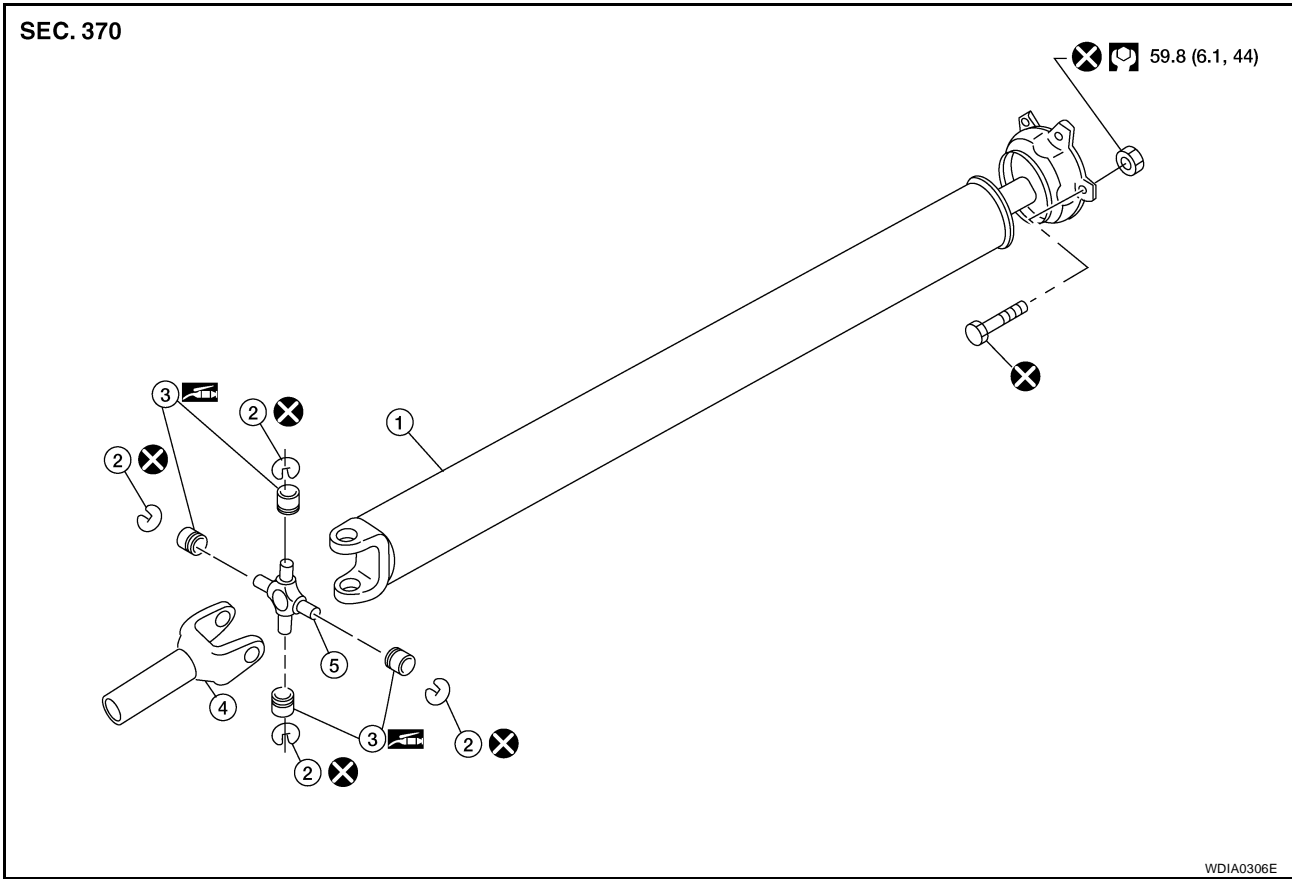
Model 2S1330-BJ100

| 1. Propeller shaft | 2. Snap ring | 3. Journal bearing |
| 4. Sleeve yoke | 5. Journal | |

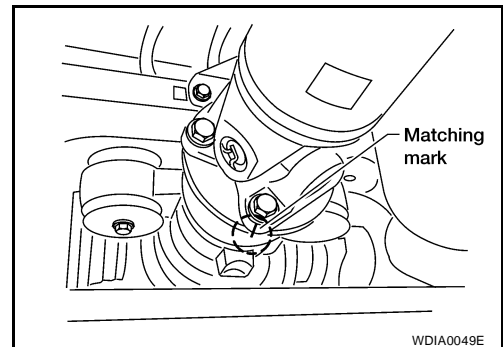
- Put the transmission in neutral and release the parking brake.
- Put matching marks on the rear propeller shaft flange yoke and the rear final drive companion flange as shown.

- Remove the bolts, then remove the propeller shaft from the rear final drive and transmission or transfer.

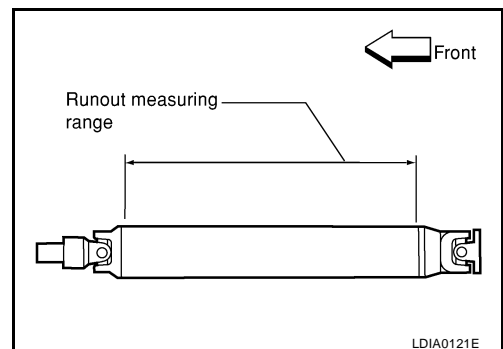
- Inspect the propeller shaft runout. If runout exceeds the limit, replace the propeller shaft assembly.

Propeller shaft runout limit

2WD : 1.02 mm (0.040 in) or less

4WD : 0.6 mm (0.024 in) or less

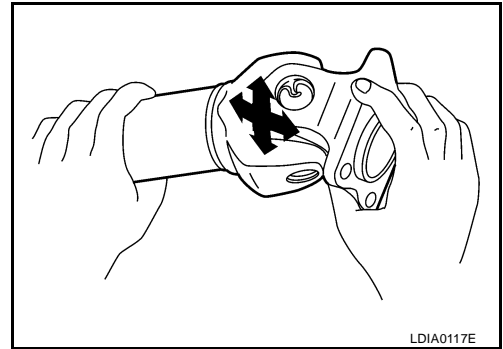
- While holding the flange yoke on one side, check axial play of the joint as shown. If the journal axial play exceeds the specification, repair or replace the journal parts.

Journal axial play : 0.02 mm (0.0008 in) or less

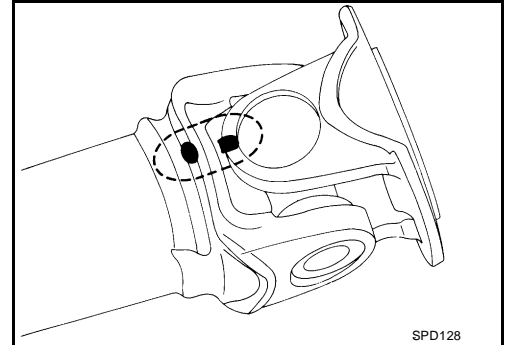
1. Put matching marks on the rear propeller shaft and flange yoke as shown.

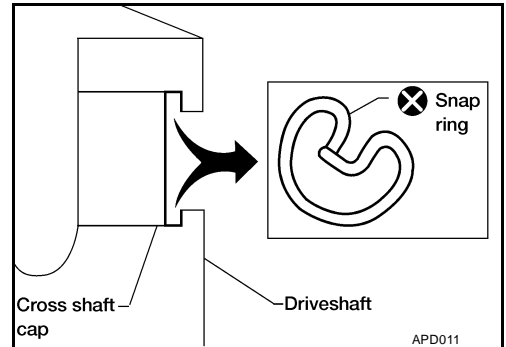
2. Remove the snap rings.

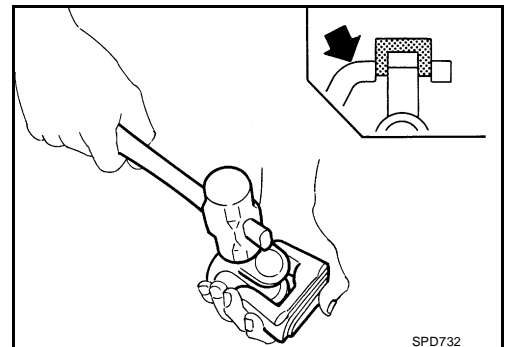
3. Push out and remove the journal bearings by lightly tapping the flange yoke with a hammer, taking care not to damage the journal or flange yoke hole.

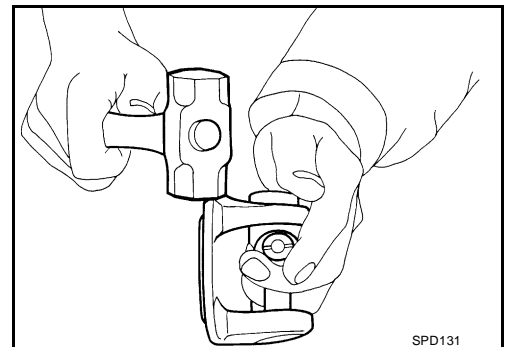
4. Push out and remove the remaining journal bearings at the opposite side by lightly tapping the flange yoke with a hammer, taking care not to damage the journal or flange yoke hole.

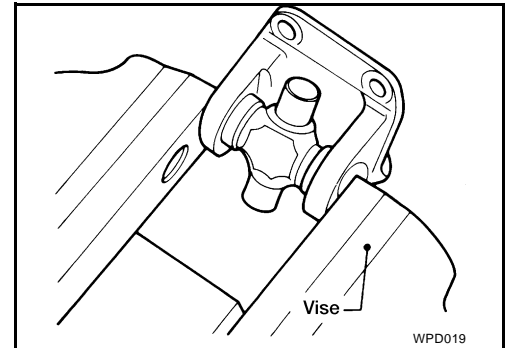
1. Assemble the journal bearings. Apply multipurpose grease on the bearing inner surface.

During assembly, use caution so that the needle bearings do not fall down.

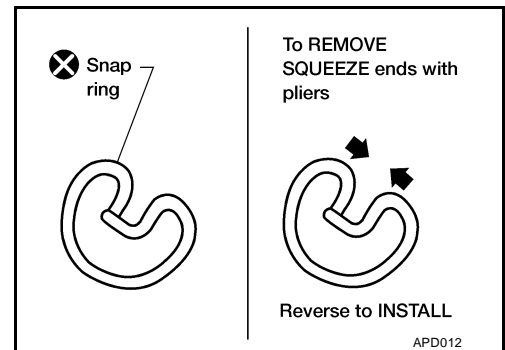
2. Select snap rings that will provide the specified play in an axial direction of the journal, and install them. Refer to [PR-16, "Snap Ring"](#).

Select snap rings with a difference in thickness at both sides within 0.02 mm (0.0008 in).

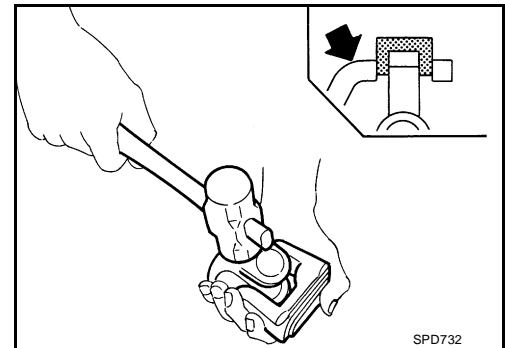
3. Adjust the thrust clearance between the bearing and snap ring to zero by tapping the yoke.

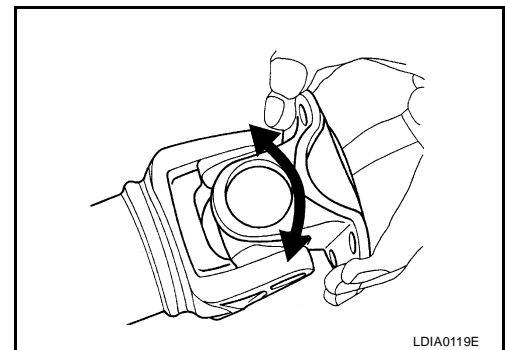
4. Make sure that the journal moves smoothly and is below the joint flex effort specification.

Joint flex effort : 2.26 N-m (0.23 kg-m, 20 in-lb) or less
